## **STROUDWATER CANAL CRANES (PART TWO)**

### **THE DUDBRIDGE CRANE**

Ray Wilson

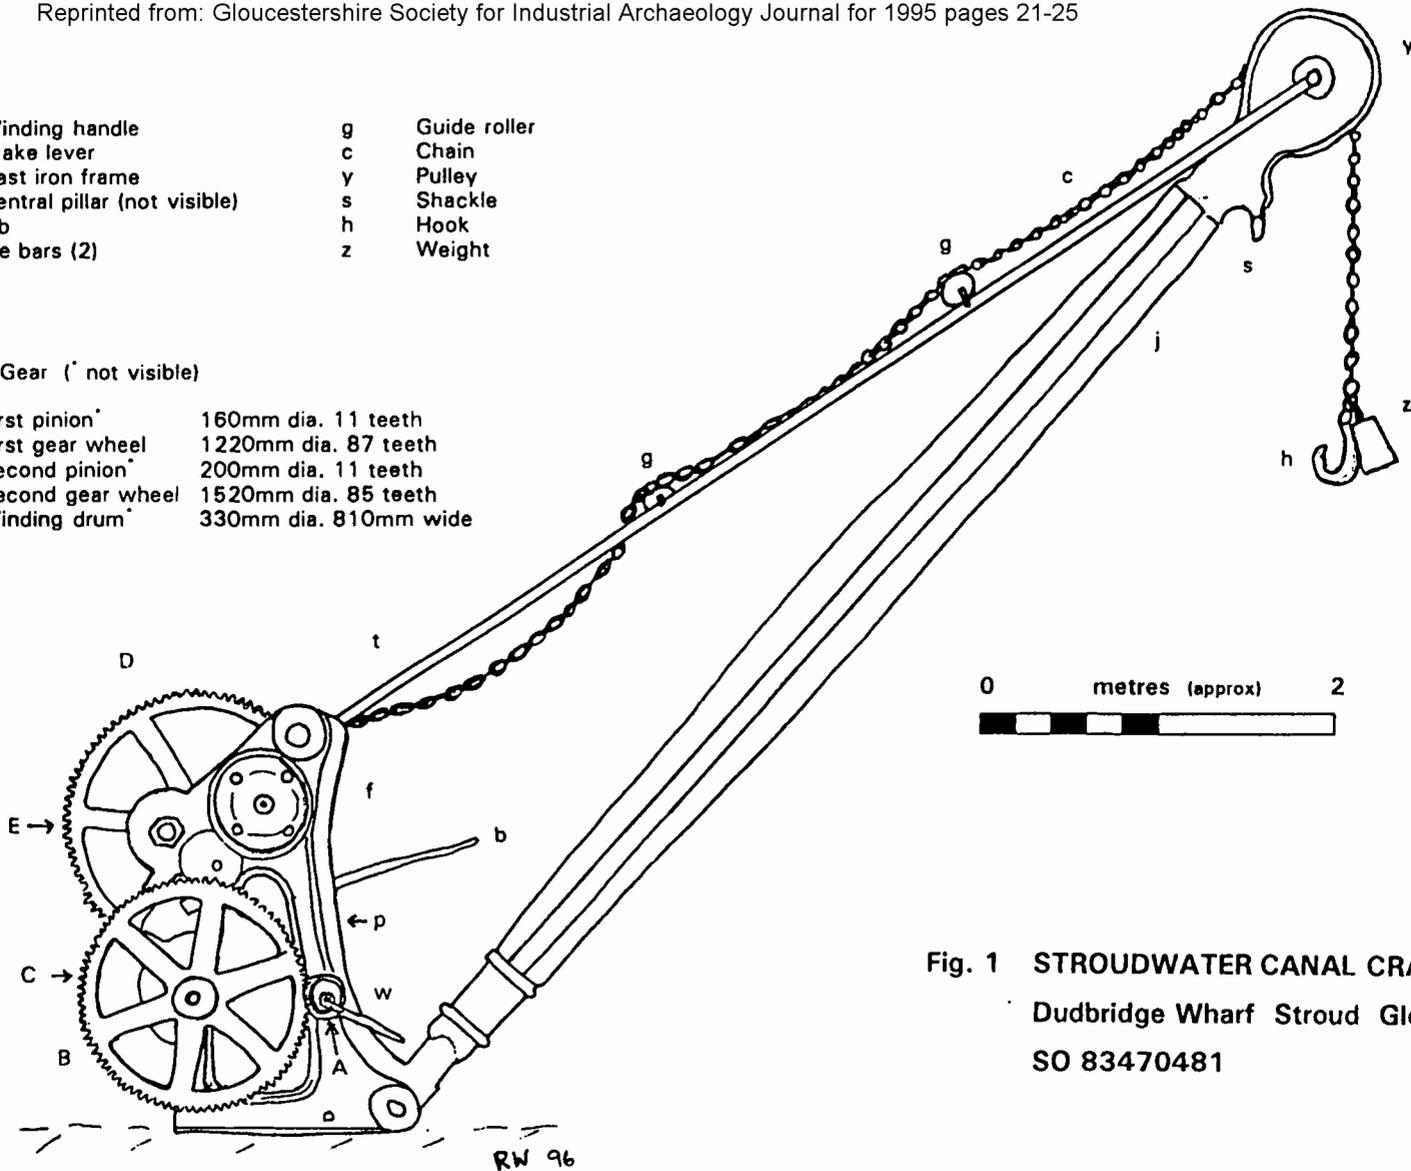
Fig. 1 STROUDWATER CANAL CRANE  
 Dudbridge Wharf Stroud Glos.  
 SO 83470481

The crane has obviously not been painted for some years and there are small flakes of rust on all iron components. However, there does not appear to be any significant loss of metal section. There are a few places, for example on the drum, where some pockmarks have occurred. It is presumed that this is a result of water ingress in minor casting faults such as blowholes. It is likely that the frame was originally painted but it is not obvious that any paint now remains from then or any subsequent re-painting. Clearly it would require a large amount of wire brushing and rust treatment to prepare properly the ironwork for painting. Some parts are very inaccessible and some dismantling would be required.

One part of the inside of the frame shows more rusting and is bright orange colour. This region should be investigated and given appropriate treatment. Advice will be sought on conservation of the ironwork as a whole, but the most appropriate treatment would appear to be to leave it in its present state apart from the small area mentioned above.

The timber of the jib appears reasonably sound although the upper side of the jib shows some flaking. The underside shows the remains of a now matt black paint or tar treatment. It is understood that it has been treated with some form of timber preservative over the years. It would seem appropriate to apply a modern timber preservative paying particular attention to the upper side. If the jib is to be painted in the future the flaking timber would have to be removed or the cavities

Most at risk are the baseplate and lower part of the frame which are submerged in the silt. It is intended to clear the silt so that these parts can be examined and recorded. At present, yard water runs into the base of the crane depositing silt and this water will need to be diverted. The winding gear and other moving parts will be greased and it is hoped that the crane will be movable again.

filled, as it would not be sensible to paint over it. At present it would appear that the colour should be black. Old photographs might show an earlier colour scheme. Alternate black and white on the eight sides might have been used.

In many respects the 140 year old crane is in very good condition and appears to be in need of only minor conservation work at present. It is intended that the society will complete the investigation of what conservation work is needed during the summer of 1996 and then carry that out forthwith. The matter of making the crane more visible to the many walkers who use the towpath will take longer to resolve. However, the structure is the last surviving crane on both the Stroudwater and Thames and Severn canals so it is an option that is well worth exploring.
