THE CANAL ROUND HOUSE AT INGLESHAM LOCK

John Copping

(adapted for the GSIA Journal by Alan Strickland)

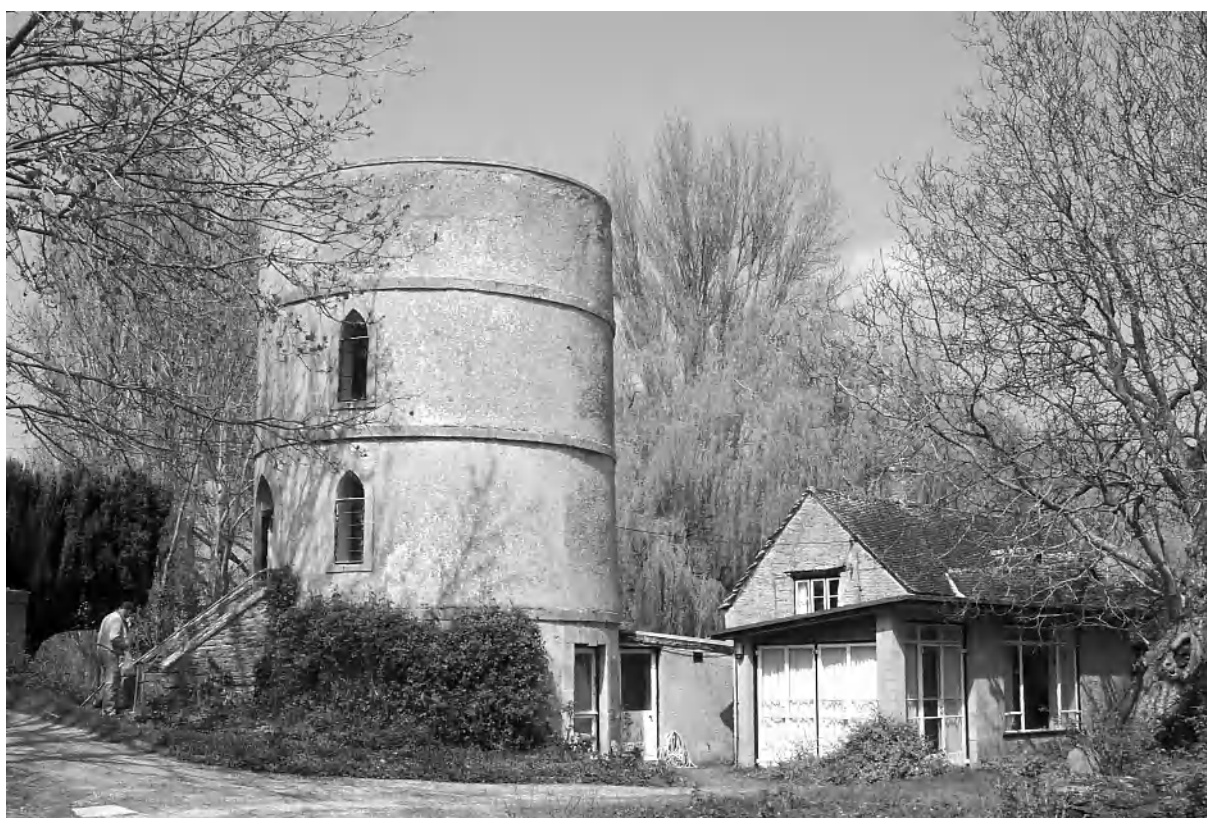
Figure 1. The round house from the south

It is asserted that round-houses were finished in stucco. It is difficult to determine absolutely that this is so. Early photographs available are sufficiently grainy so that it is not possible to determine wall finish with any assurance. At Inglesham, the old rough cast stucco, of which some ten percent has been patched, is in mixed condition, substantial areas having lost adherence to the base.

The top storey at Inglesham round house appears to be of coursed rubble limestone, that is likely to be the same as the build of the wall structure beneath the external rendering. It is apparent that pointing with lime plaster would be a quite adequate finish for the external walls - some of the other round-houses today stand unrendered. This poses the question whether they were rendered originally, as suggested in the literature, and if so why?

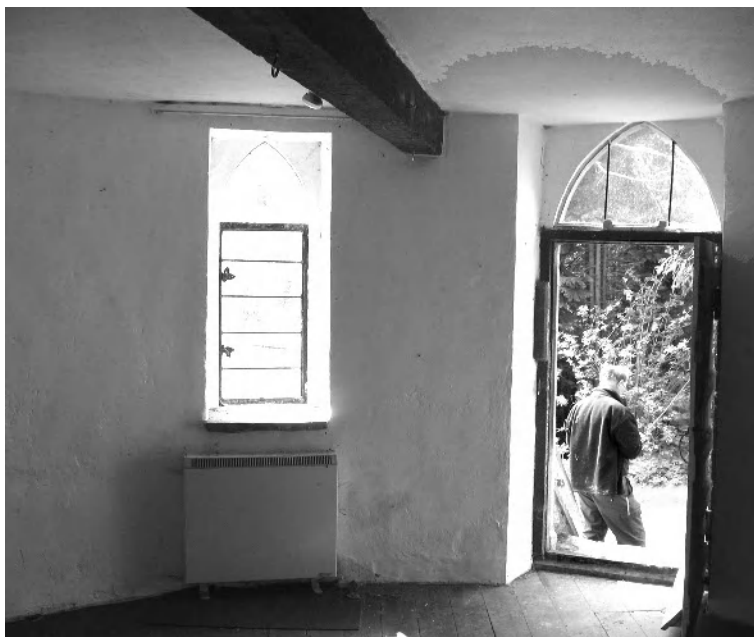
Figure 8 Lower Floor:
Support beam
▼

The position of the opening casement on the other side is to the left of the symmetrical position, apparently to provide sufficient mass between it and the door to support the single beam supporting the ceiling, which is as a consequence offset (Figure 8). As below it appears to be a replacement, bearing the carved initials MN. The pine floorboards

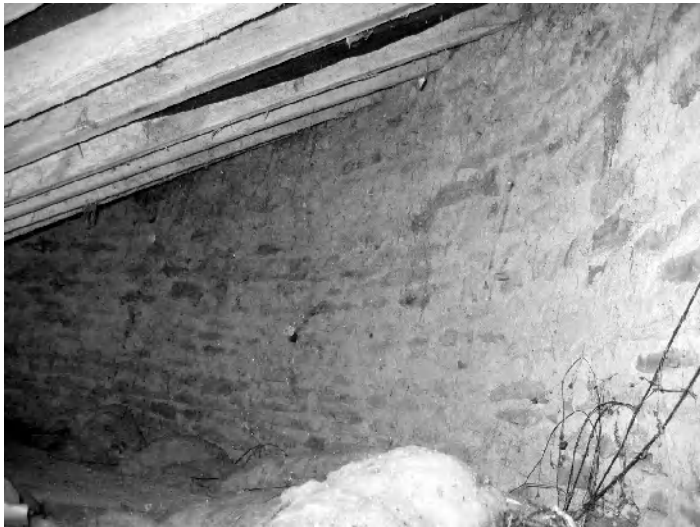
▲ Figure 9 Space beneath conical roof

There is an access hatch in the ceiling, apparently built in recent times, to the space below the inverted conical roof (Figure 9). This collects rainwater and

Evidence remains of the lead-work at the bottom of the funnel leading into the conduit below and from there to the external hopper and down-pipe. It seems inconceivable that the whole inverted cone was not lead lined. It is noticeable that the conduit is a couple of inches deep in water. This could be caused by a blockage of the outflow, but that appeared unlikely. It is more probably intentional in order to keep the sheets of lead lining the conduit cool, thereby minimising chance of fracture by expansion and contraction between night and day temperatures. There is no indication that the system was ever intended to provide a cistern at roof level.

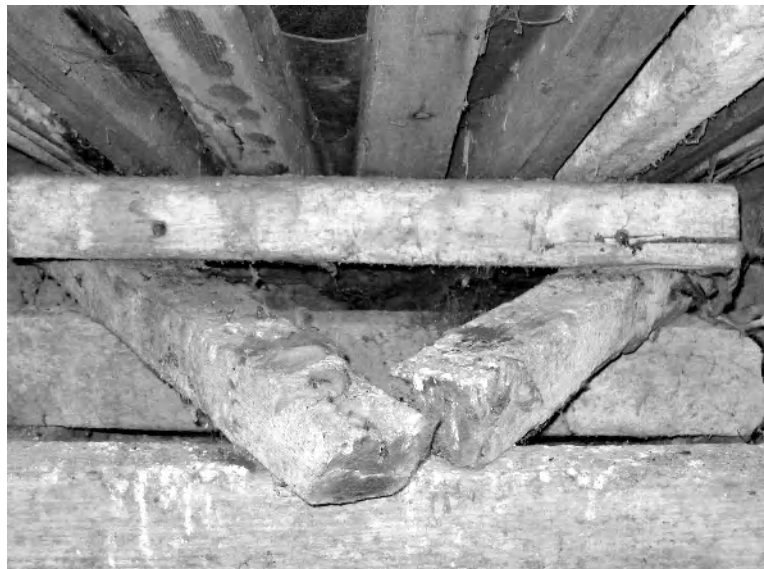
▲ Figure 10 Timbers supporting roof

channels it from its centre to the cast-iron hopper and down-pipe on the face of the building opposite to the front door. A modern glass roof-light permits access to the exterior towards the top of the westward side of the inverted cone. Apart from some timbers around the new access hatches, the supporting timbers appear original (Figure 10).

exterior, which is not directly visible from below. The environment of the roof-space is not good, carpeted with dusty insulating fibre so recording was limited to photographic form. The support structure is original with the exception of the new access. The weight is supported by two cross-beams supporting the outflow channel. On this is built an octagonal structure of short beams onto which are laid the timbers forming the inverted cone form of the roof.

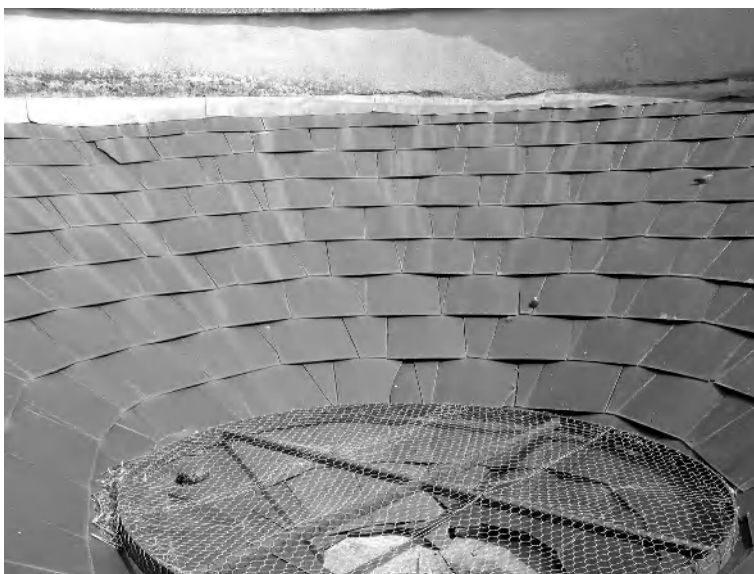
▲ Figure 11 Roof surface

The roof surface (Figure 11) has been rebuilt with synthetic slates

but an area of lead surrounding the centre orifice suggests that the entire original lining was in all probability lead.

The parapet coping, the flashing and rendering above the new roof slates are recent work . Dead foliage in the roof-space is the residue of the creeper cover shown in a 2002 photo, which therefore pre-dates the re-roofing.

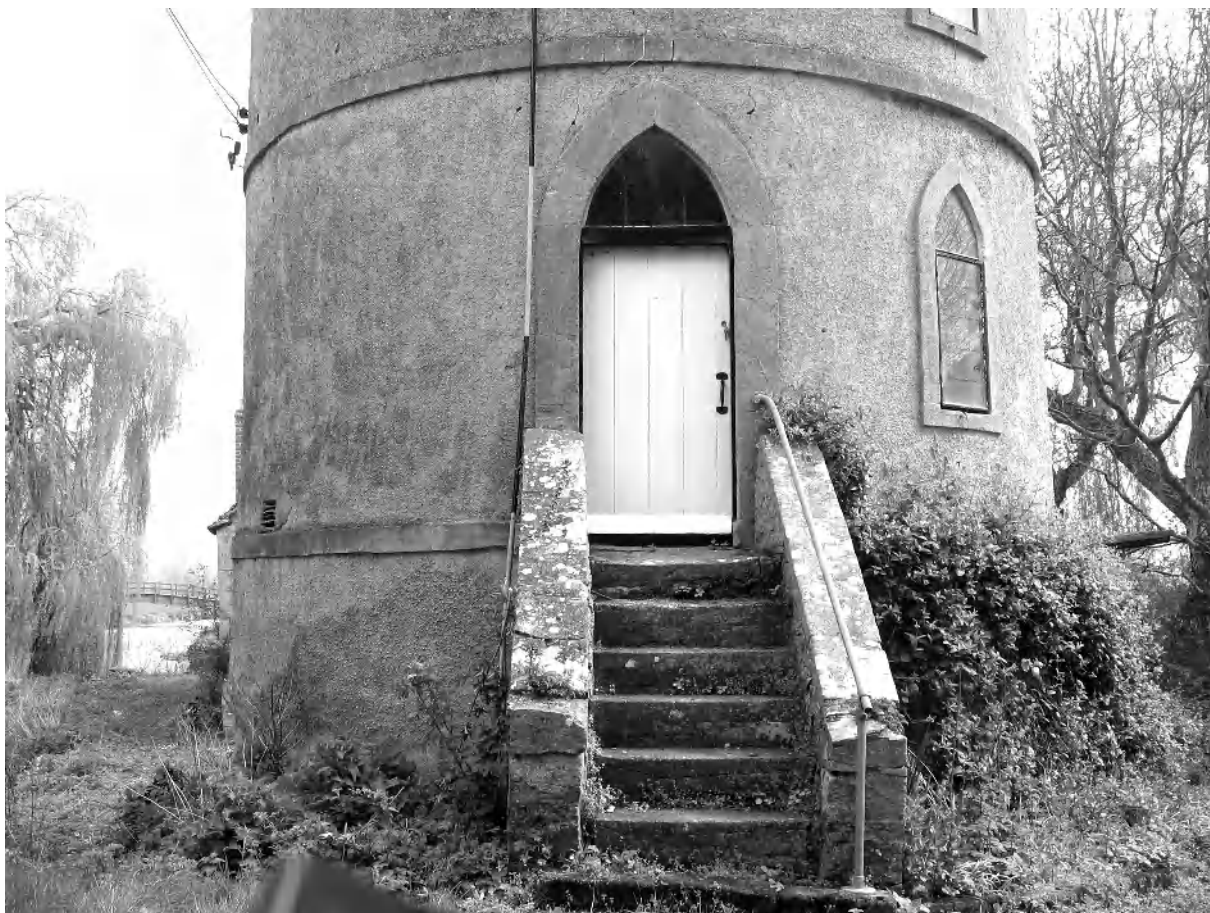
Figure 12 Steps up to entrance

The steps to the entrance (Figure 12) also raise questions relating to this dilemma. The mass of the stone staircase is falling away from the face of the building, there being no bonding between the two. The coping of the side walls of the steps is of rough stone where one might expect a dressed parapet to match the door surround had they been part of the original design. The conclusion might be drawn that the steps are later. A painting of 1793 shows steps, clearly those that exist today: had they been built with the tower, would they not have been rendered to match the walls?

It seems possible that the original building was not planned with the present staircase as an integral part and that the stairs were added shortly after the building was completed, possibly built by a different contractor. It is a moot point whether that was the reason they were not rendered, whether they were sufficiently 'separate' for difference in finish to be unimportant, or perhaps that they were left unrendered because at that stage the round-house itself was not rendered. For some reason the steps are also not symmetrical to the face of the building.

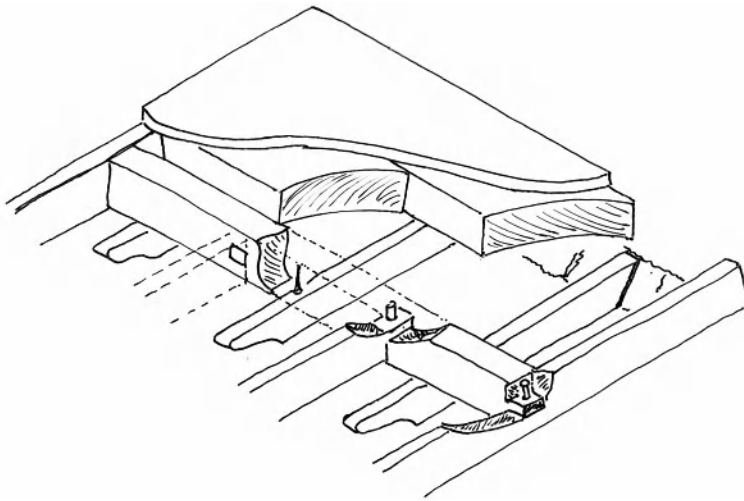
Figure 13 Grate Support Frame

This ingenious piece of coarse structural engineering (Figure 13) was evidently contrived to provide support for the relatively modern apron in front of the fire. That could have been provided when the present stove was installed, which was certainly since the last war. The surround could however have been extended to accommodate an earlier change of stove and so considerably pre-date the installation of the present one.

The cross-timber is mortised into the two replacement joists. The two heavier timbers appear to be lengths of railway sleeper. Their weight and that of the fireplace above is supported by the spurs below, which rest at the wall end on a slope forming part of the original wall. This sloping

feature may relate to the provision of draft for the chimney above. At the open end the spurs are bolted upwards into the cross-timber. Two factors suggest that this assembly is of some age. The mortise and tenon joints were clearly cut by hand and are then locked by dowels which are also hand-cut. The weight-bearing spurs hang from their supporting member, held there by what appear to be wrought metal pegs, possibly having a slight spiral form to help adhesion, as they are operating in tension. This form of fixing device is considered likely to date from c1900. The conclusion is drawn that the apron hearth was extended around the turn of the twentieth century to accommodate a changed form of fire or stove between the original, probably a small range, and the current one. There might of course have been more changes than that.

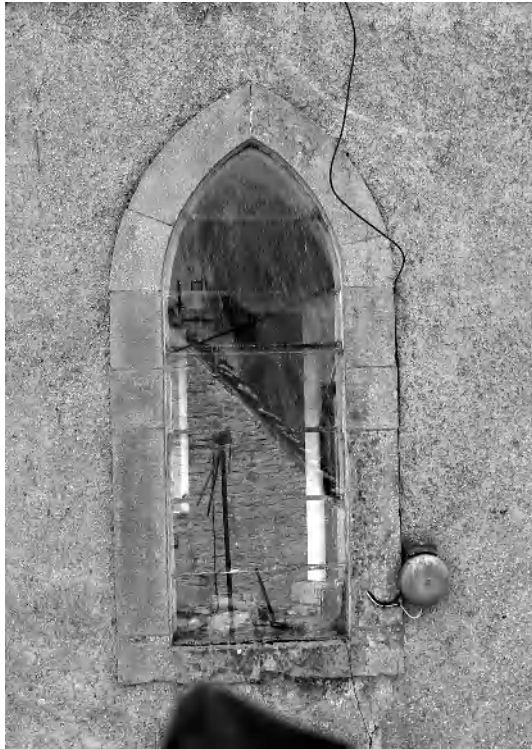
Figure 14 Window (lower floor, east elevation)

The four windows are small pointed-arch single lights with plain stone surrounds (Figure 14). The upper door aperture is in similar style. These and the three stone bands between floors are all of the same variety of dressed stone.

The lower portal is of consistent section but rectangular. This set provides the building with an elegant 'presence'. All windows have modern float glass but the frames of the one fixed and three opening lights are old, each having the horizontal iron bars used for the ties to support leaded lights.
