MILLEND MILL – THE END OF AN ERA – PART 1

Stephen Mills

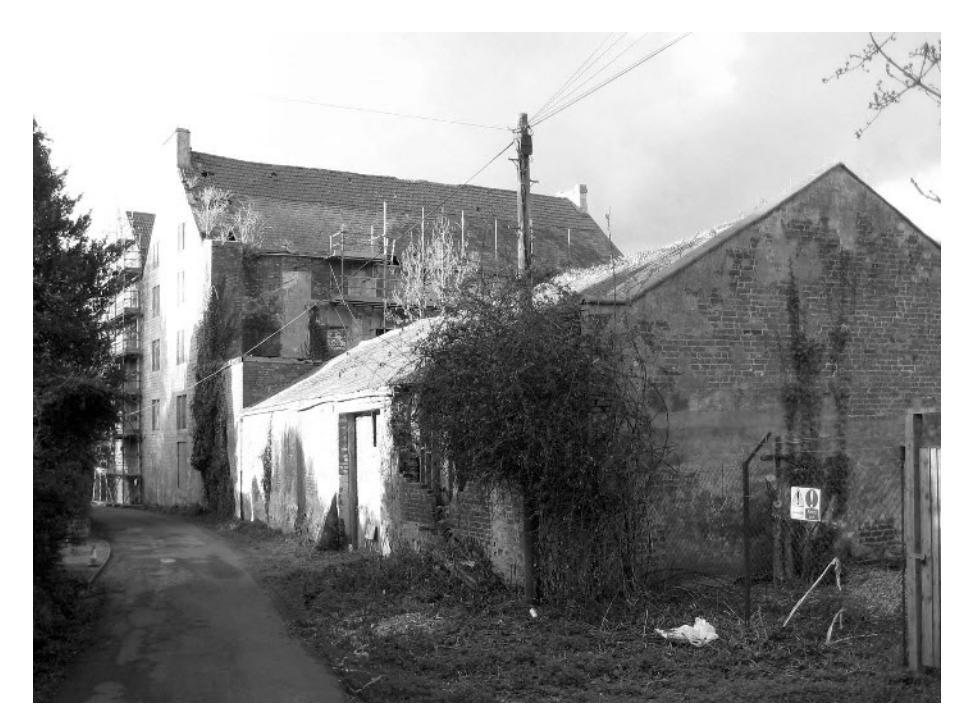
Fig. 1 The rear of the mill showing part of the complex jumble of buildings added at different periods.

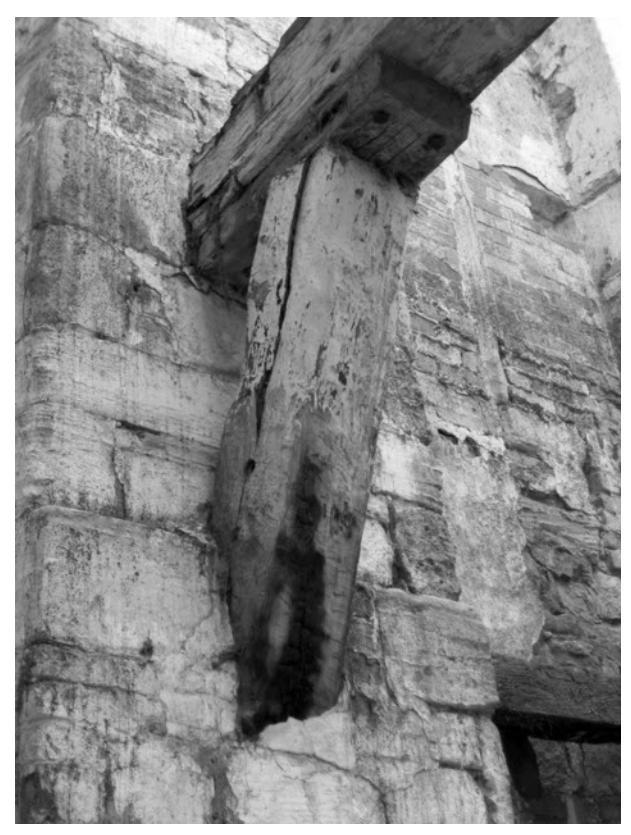
Fig. 5 Charred wooden joists, reused in the Sleeman's rebuild following the 1920s fire.

A shortage of money would go some way towards explaining why the mill was rebuilt as it was. During the demolition, innumerable examples of cost-cutting came to light. Repairs had been bodged, and even charred floor joists salvaged from the fire-ravaged mill had been re-installed (Fig. 5). Else-

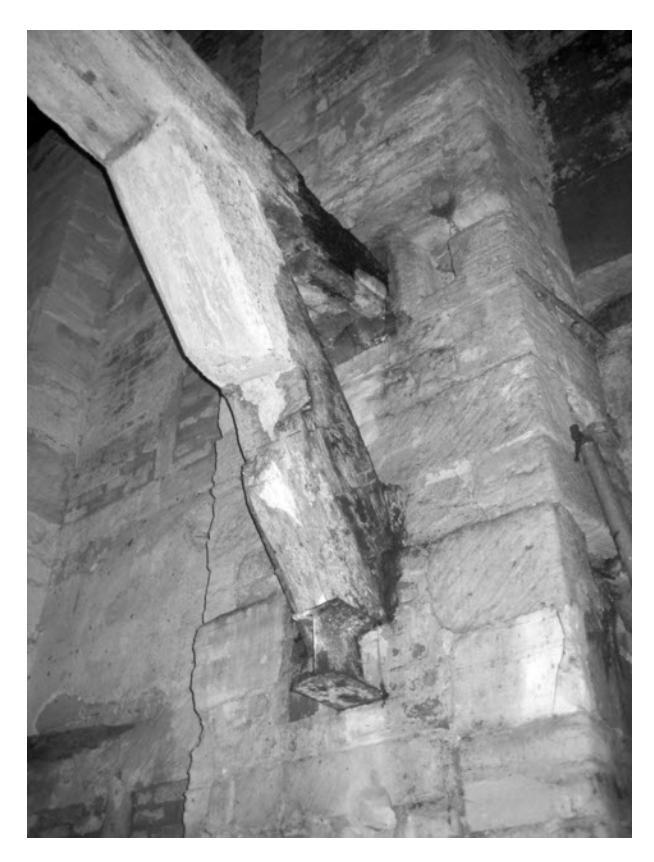
Fig. 6 The floor heights were increased by raising the floors on crude supports carried on short lengths of iron girders set into the original joist holes. Clearly, the timbers were re-used.

short lengths of iron girder into the original joist wall sockets, then raising the floor by means of crude supports (Fig. 6). It seems likely that these significant changes were made during the mill's rebuild following the disastrous 1920s fire. Despite being quite badly charred, a number of beams etc. had been re-used.

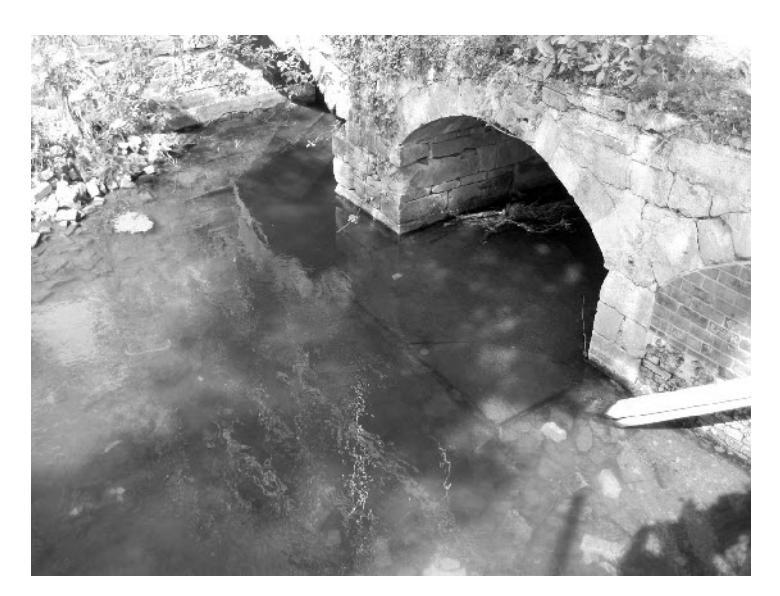
Fig. 7 The inlet arches to the mill's three wheel pits. The right hand one has been bricked up. An iron flood gate lies on the river bed in front of the left hand arch.

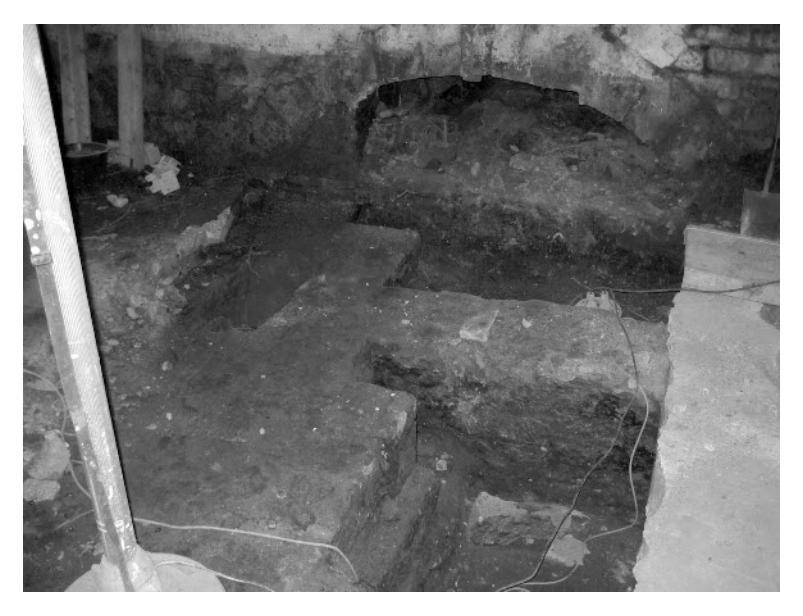
Fig. 8 The excavated left hand wheel pit, narrowed and reconfigured to accept a smaller wheel of unknown dimensions and use. The function of the small internal walls is not known.

Here, the 8ft wide pit had been infilled and its inlet arch bricked up. Excavation revealed that at some point, the original large water wheel may have been replaced by a smaller unit. At the upstream end of the pit there was a small section of the curved wall visible, plus a central dividing/supporting wall had been inserted in the pit. This appeared to have been constructed using masonry robbed from original left hand pit wall, effectively reducing the width of the pit (Fig. 8). Recesses in the masonry of the narrowed pit walls suggested possible bearing locations. The width of the supposed wheel was around 30 in. although there were no indications as to its diameter or function. Various other brick and masonry walls had been built within the confines of the narrowed wheel pit, possibly associated with water inlet and outlet. An angled block of masonry on the outlet side seems to have been part of the outflow control system.

The pit had been filled with masonry, rubble and burnt wood, suggesting a pre-fire date. It has since been refilled and covered over again with a modern concrete floor.

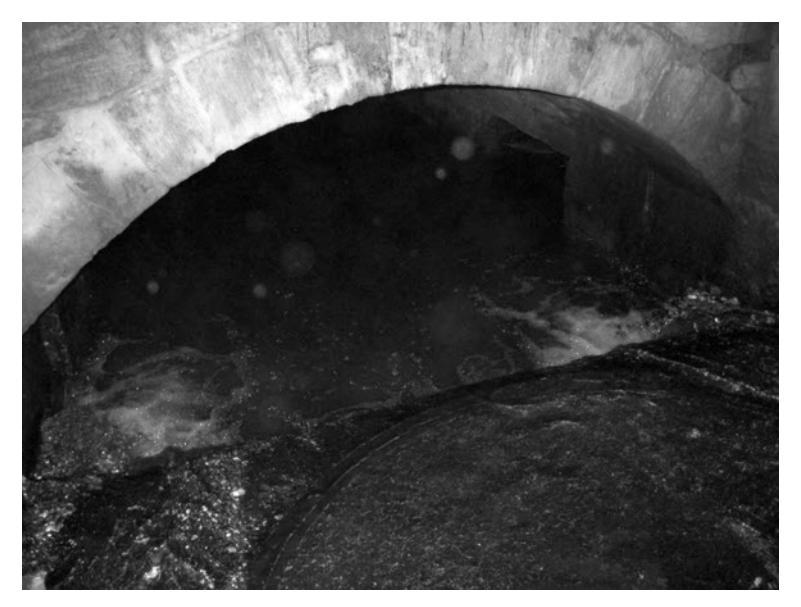
Fig. 10 The turbine's outer casing survives in situ, but now filled with concrete. The outlet arch behind was once blocked with a wall to retain sufficient head of water for the turbine

The iron outer iron casing of the turbine (of around 7 ft in diameter) survives in situ, but now filled with concrete (Fig. 10). The floor of the wheel pit has been similarly raised so that it is now level with the top of the turbine body. Presumably, this was done when the turbine went out of use and was to ensure that water could pass unhindered through the, now unused, wheel pit. It may also have helped minimise the risk of blockages resulting from the inevitable

detritus carried down the river. The depth from the top of pit down to the top of concrete infill is 64 in.; the depth to the pit's original surface is 79 in. Therefore, the turbine's outer casing is 16 in. deep. The Gilkes sales catalogue of 1900 lists a low head unit of 6ft 10 in. diameter, so this matches the diameter of the surviving turbine casing. This sized unit should have a depth of between 15-16 in., adding further weight to the conjecture that this was a Gilkes turbine.

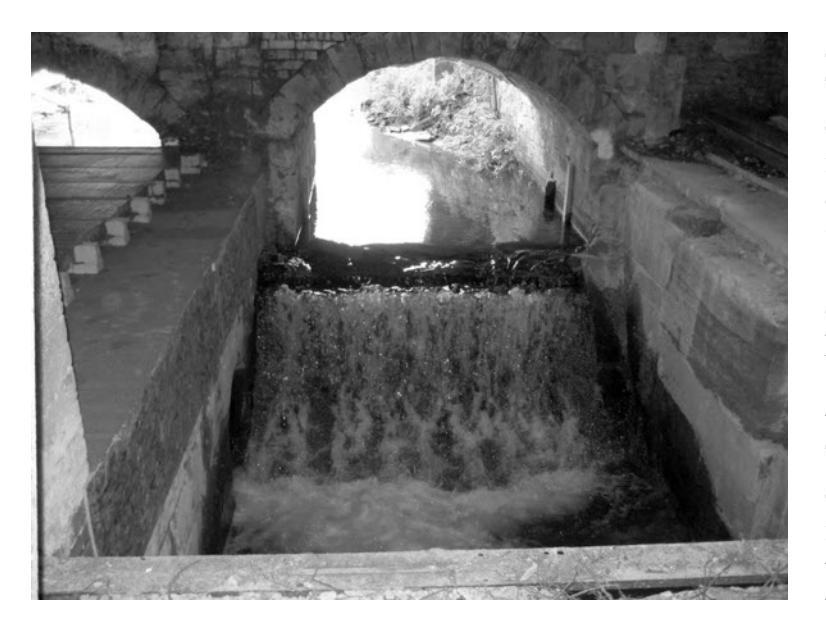
Fig. 11 The right hand wheel pit and inlet arch following removal of the 1920s concrete floor. The middle pit (to the left) has already been recovered with a new concrete floor.

When the poor quality concrete floor covering this wheel pit was removed, it was discovered that it had been supported on a motley collection of bits of iron work, timber, even several old doors (complete with hinges!). On this basis, it seems likely that this floor was put down after the 1920s fire. Shoddily and cheaply constructed, it smacks of cost saving. It is nothing short of a miracle that it had not collapsed at some point. Like the middle pit, this one remained open but still retained its full depth, although at 10 ft 8 in. in width, it was slightly wider (Fig. 11). All three pits appear to differ slightly in width.

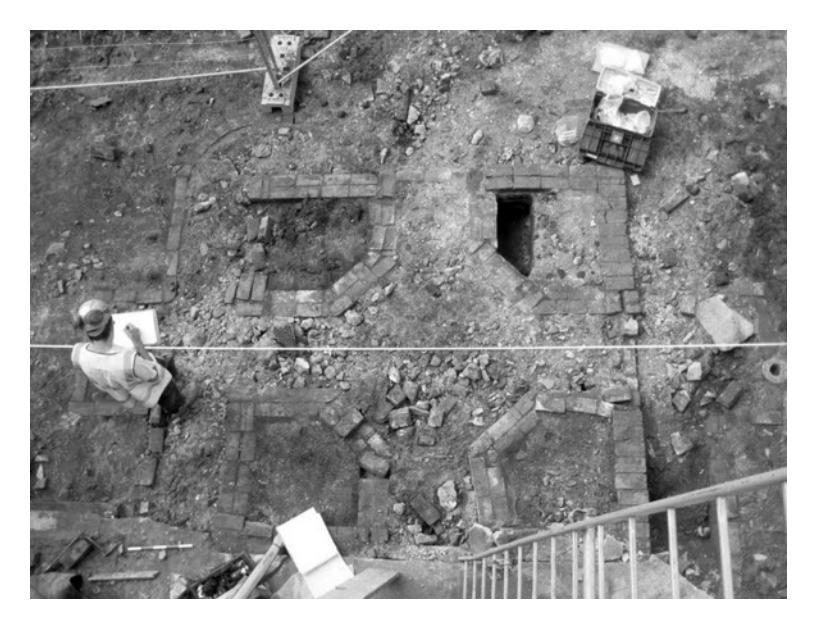
Fig. 12 Excavation of the unusual kiln base arrangement revealed after more than a century. Removal of a post-malting concrete floor revealed the structure.

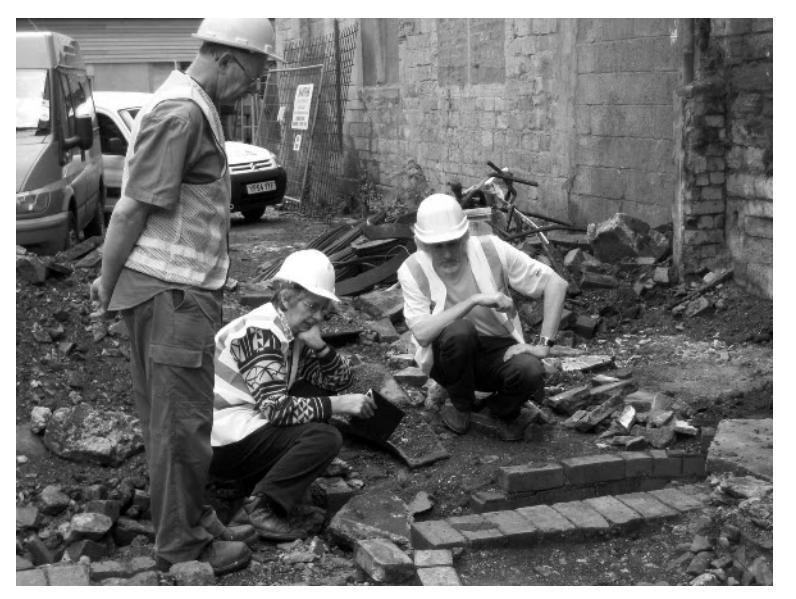
Fig. 13 Ray Wilson, Amber Patrick and the writer examining the kiln remains. Excavation revealed burnt malting floor tiles, brick rubble, pieces of anthracite and even grains of barley!

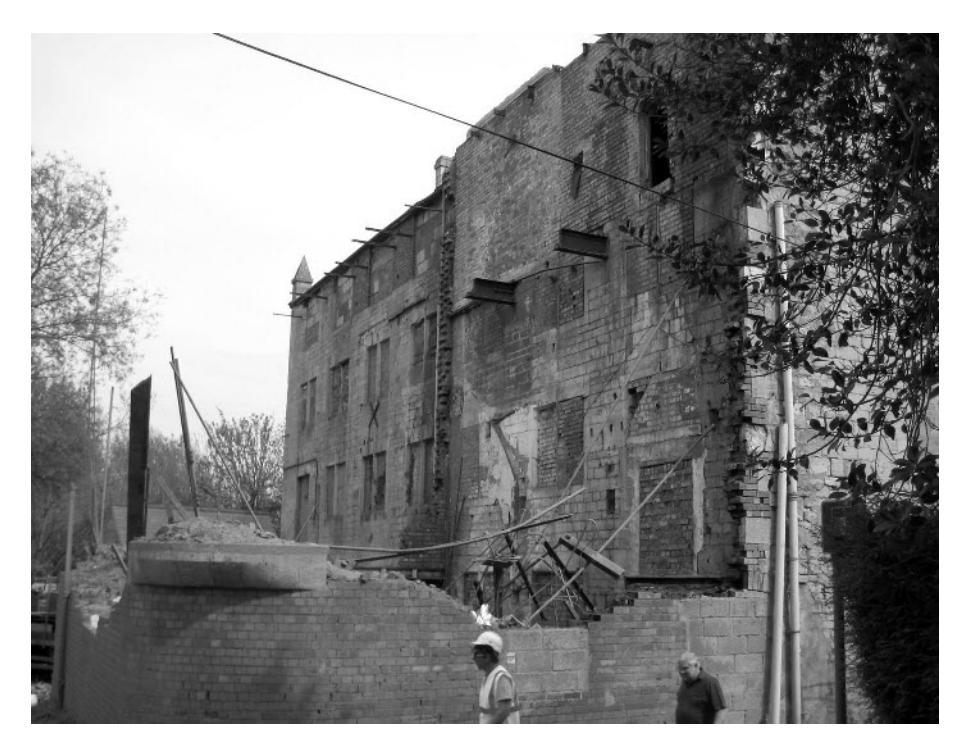
Fig. 15 The front of the main mill during demolition of the malting kiln, exposing the front wall for the first time in nearly a century. Interesting details were exposed, even a fragment of an original leaded window complete with glass, presumably dating from the mill's construction.
