The 'Great Bristol Road Lock Disaster' of January 1923

Stephen Mills September 2014

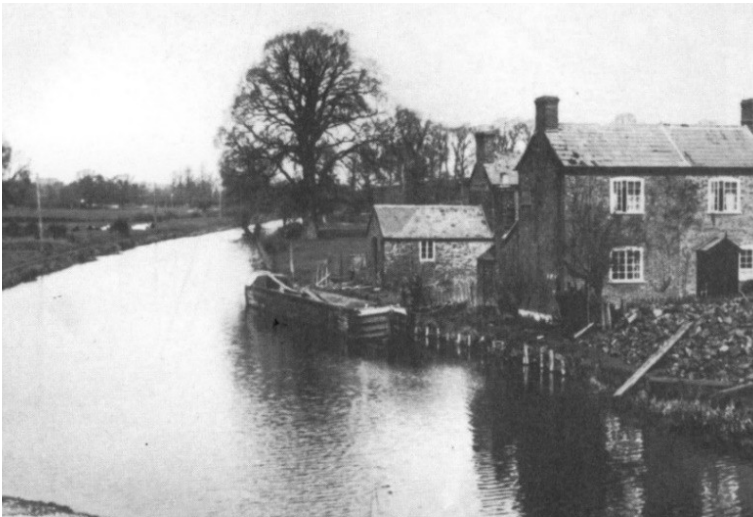
Figure 2 *The Bristol Road was a canal company wharf with good access to several local villages. Coal was the most important cargo. In 1777, the lock keeper was Joseph Grazebrook. This view is looking downstream from the bridge, c1920.*

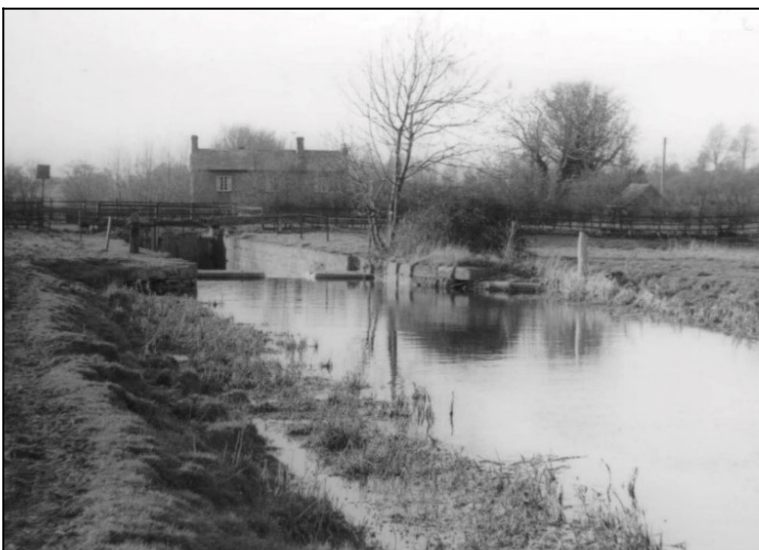
Figure 3 *Bristol Road Lock, looking downstream to the coal wharf.*

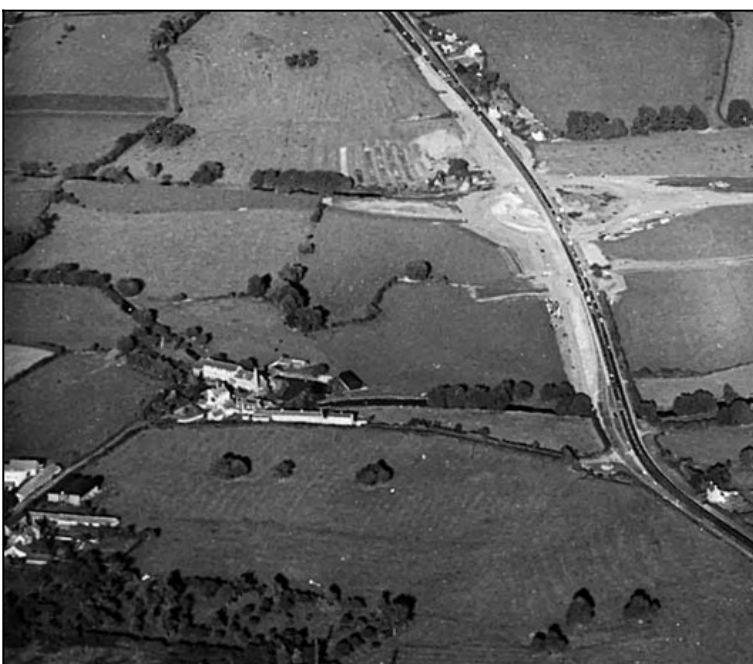
Figure 4 *Aerial view of the A38/M5 interchange under construction, taken by the late Tony Ashby in 1964-5. The Stroudwater Canal can be seen leading up to the new roundabout under construction. At this time, the bridge was demolished and the lock infilled. Fromebridge Mill is in the centre foreground.*

The Bristol Road lock subsequently disappeared beneath the large roundabout that links the A38 Bristol Road with the approach road to the Stroudwater Junction (J13) of the M5 motorway (Figure 3). The present access road to Fromebridge Mill also now exits the same roundabout. During the past few years, a new canal access has been built through/under the roundabout as part of the plan for the canal's eventual reopening.

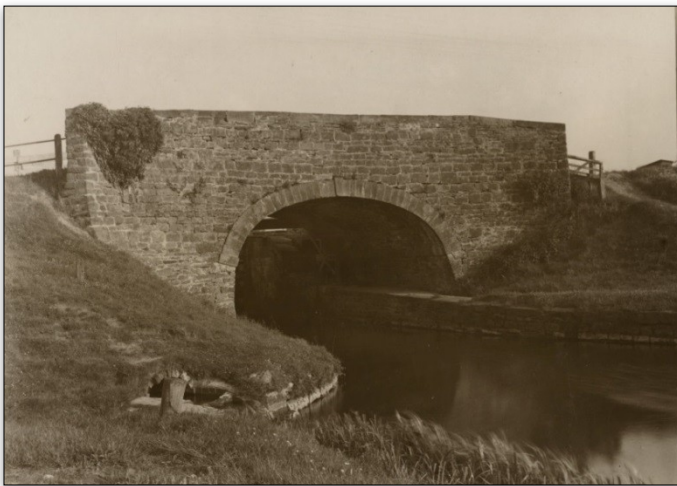
The lead (engine-driven) boat of the two was the *Alfreda*, towing the *Dorothy* behind. The combined crews comprised Mr Dowdeswell and two other men, one of whom ran forward to check that the Bristol Road lock (Figure 5) was clear. However, it transpired that the upper gates were open. The man shouted back to the narrow boats but for some unknown reason, *Alfreda* continued forward, crashed into one of the lock gates and stuck firm. In the darkness, *Dorothy* quickly came alongside and hit the other gate, presumably broke it free from its hinges and brought it down.

Figure 5 *The rarely-photographed Bristol Road Bridge, looking upstream. The lower lock gates are visible through the arch of the bridge that once carried the main Gloucester-Bristol road (now the A38). The bridge and lock were built by James Bough (1770-1830), also responsible for building various other local locks and bridges (4). The photograph was taken c1920 by the late Mr S Pitcher (courtesy Gloucestershire Archives).*

In accordance with your request I have inspected the broken lower lock gates and from my examination I find evidence that the gate on the North side (or offside) had been struck with considerable force on the iron langett or T iron about 18" from the mitre of the gates. This would have the effect of bursting the gates open for a certain distance and considering the fall in the lock at the time of the accident at about 8 feet, the resulting back pressure was too much for the gates to stand and they were carried away.
