## H O R S E   H I T C H E S

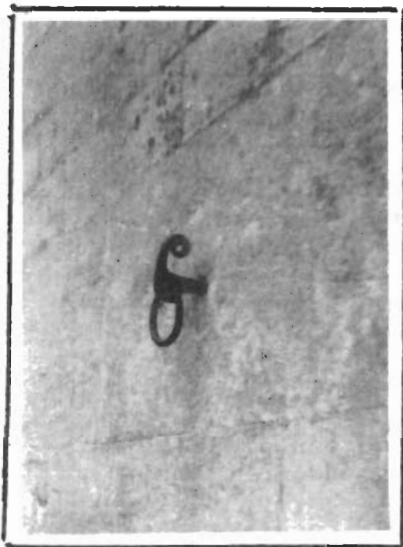
Many such rings still exist, projecting from the walls of the more important houses or inns. The example shown in the upper photograph is in the wall of the Stirrup Cup (formerly New) Inn at Bisl y.

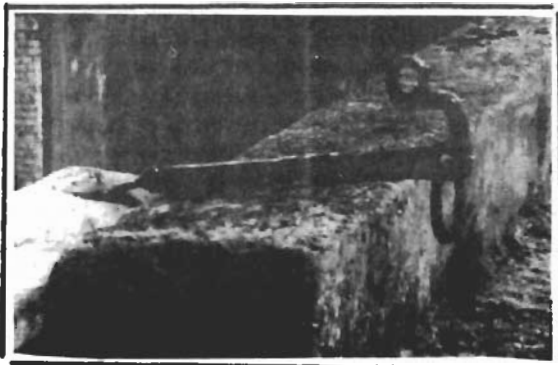
But HOW were they actually fixed in the wall, so as to prevent a headstrong horse dragging its tether free? Specimens in the Stroud Museum reveal all. Extending back from the ring & hook is the rest of the iron bar, about 4 ins. in height, 1 in. in thickness. The far end of the bar is hammered flat (oval or rectangular) and the whole is fastened into the wall by 3 or 4 long nails. The outside diameter of the ring is just under 3 ins., the hook 2 ins. high; total length of bar, ring & plate is more or less 20-23 ins. Dimensions vary between examples.

(The example in the lower photograph is by courtesy of the Stroud District Museum.)
