A NOTE ON STOWELL MILL

Stephen Mills

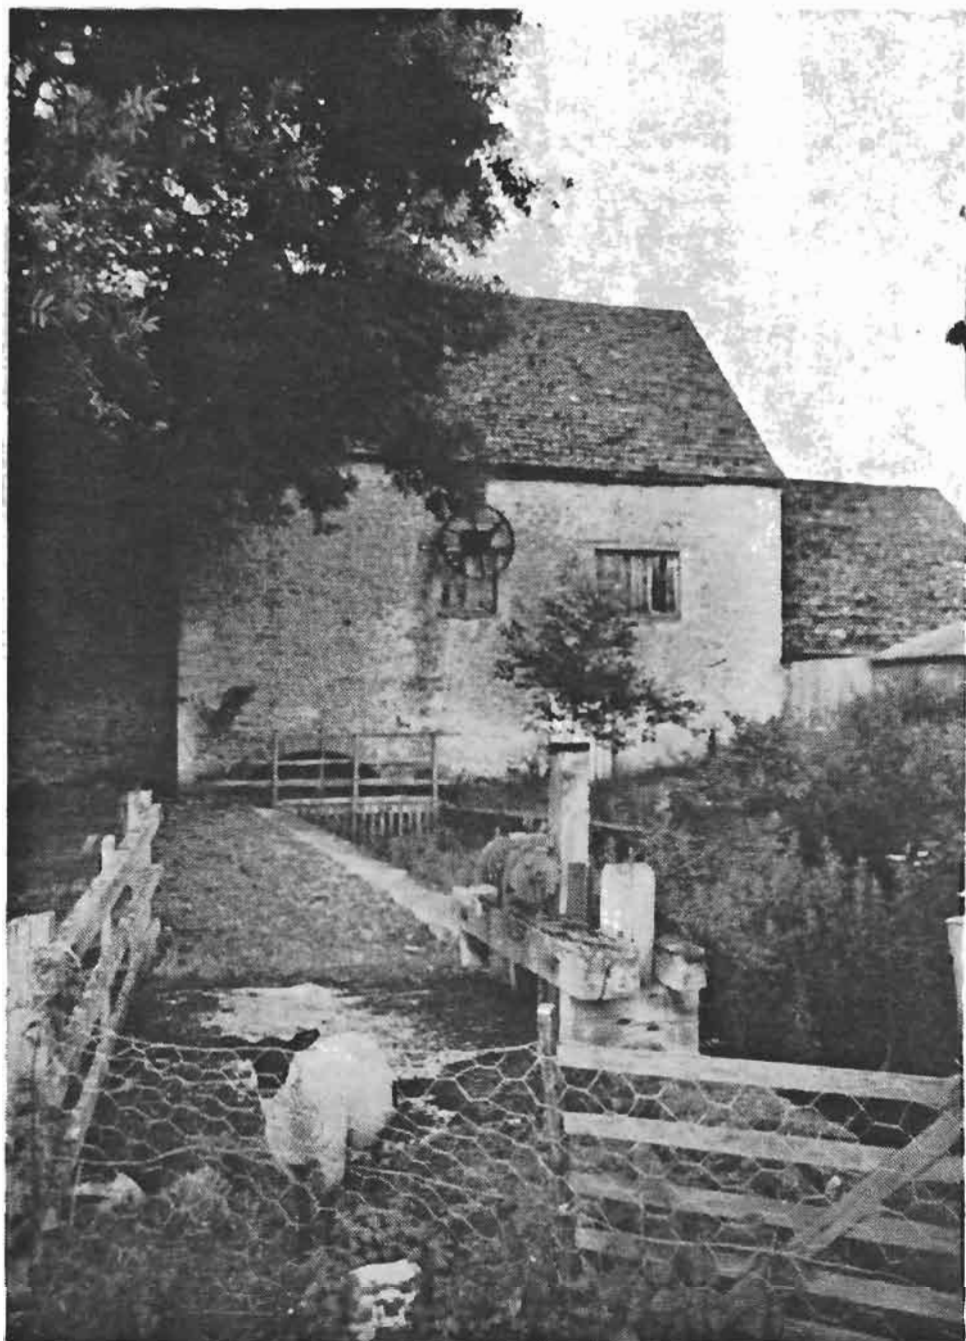
STOWELL MILL: EXTERIOR

Doubtless the present Stowell Mill would have been rebuilt/altered on various occasions, the present building being constructed of Cotswold stone with a matching stone slated roof. The latter was apparently repaired around three decades ago, and little else seems to have been done to the mill since, however, structurally it appears to be in very good condition.

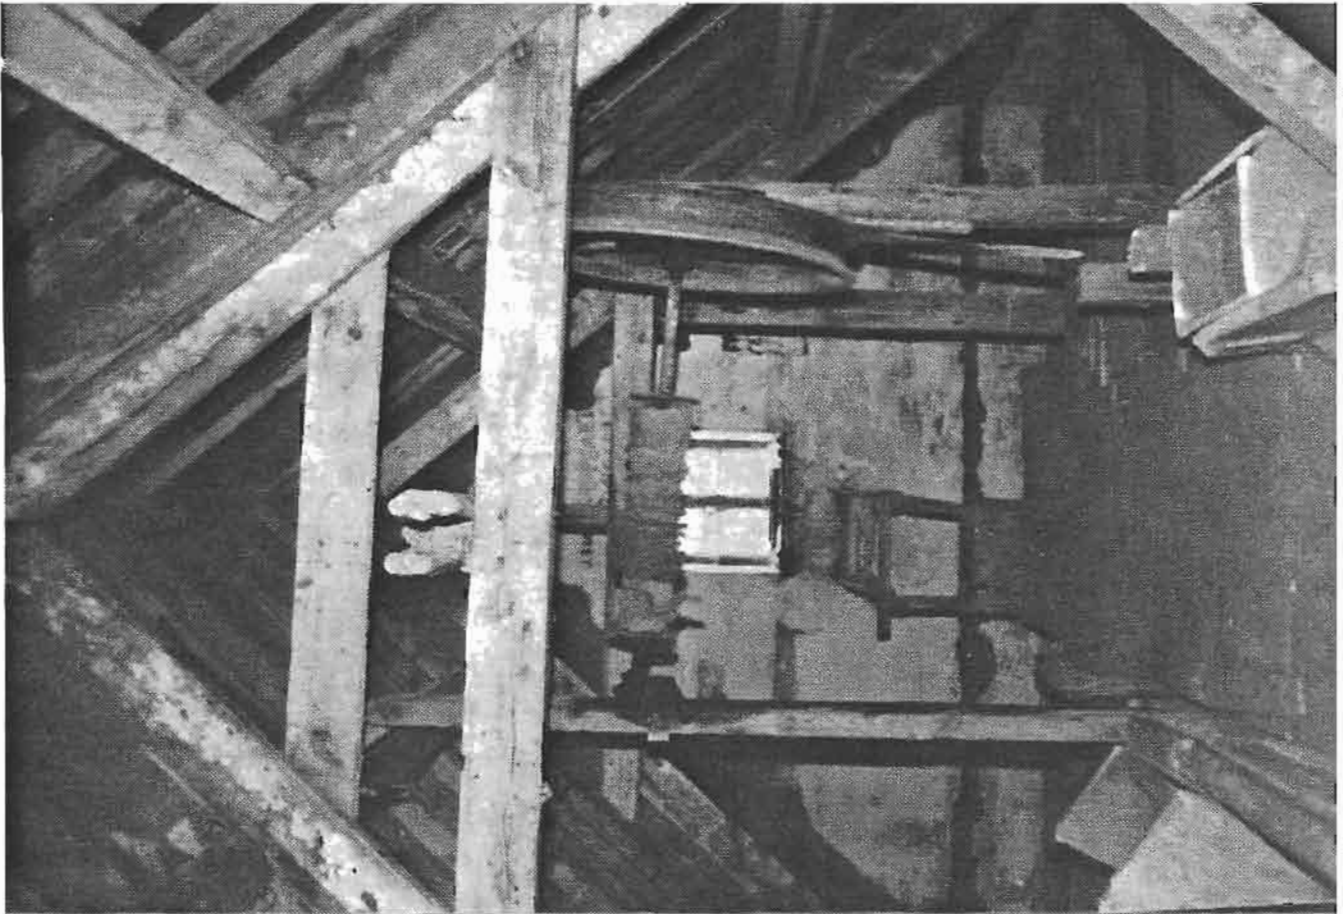
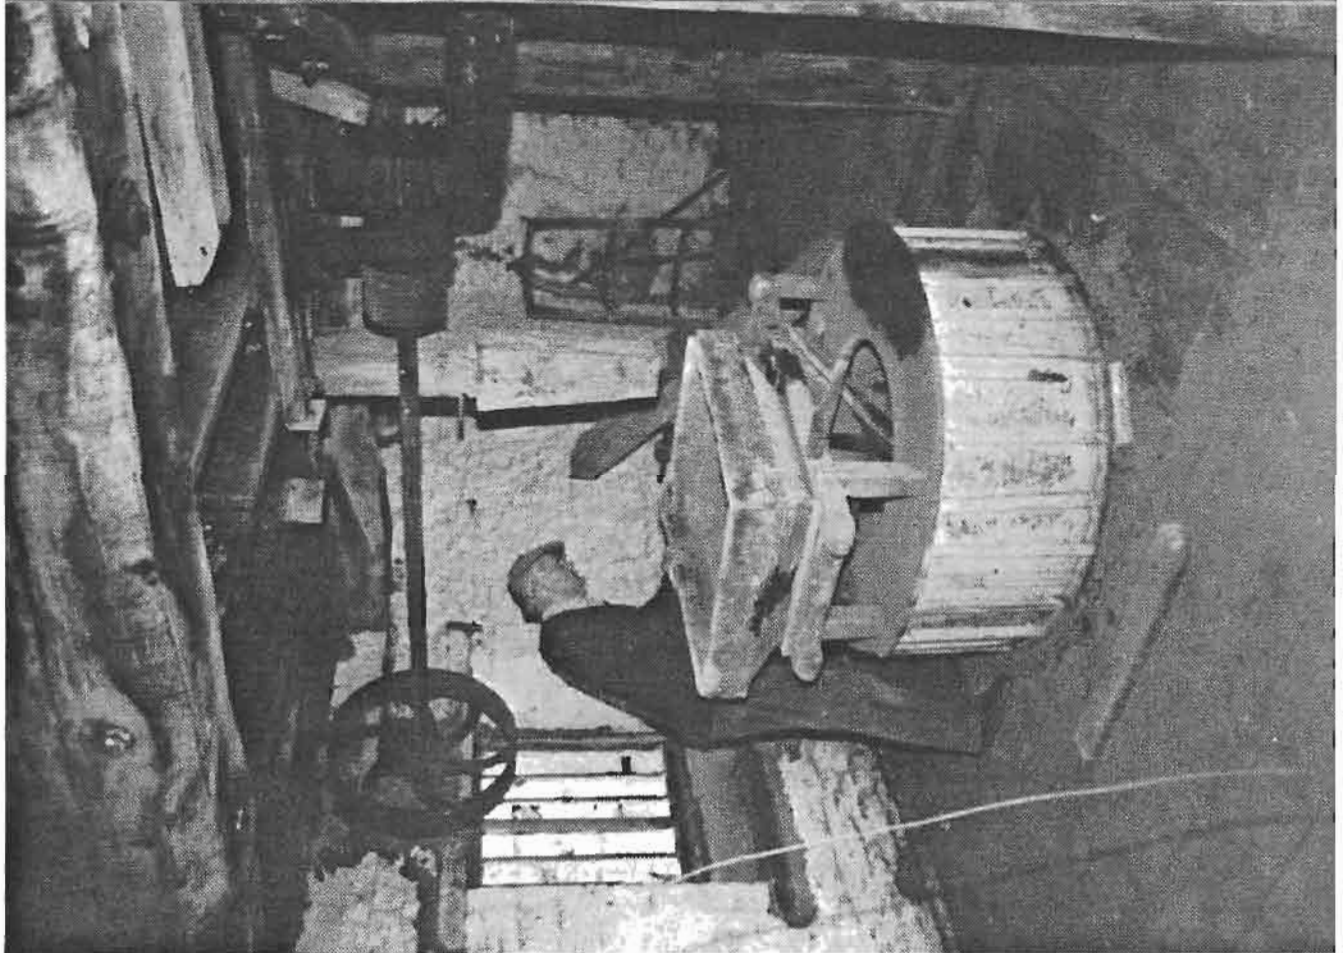
STOWELL MILL: INTERIOR

stone arched tunnel, flowing back into the Coln just downstream of the adjacent road bridge. Power is taken from the pit wheel (of ca 10 ft diameter and of iron construction, with individual wooden teeth) and thence via a pinion gear to the 10 ft diameter all-wooden wallower. Off this, two 18 inch diameter wooden stone nuts take the drive to the two pairs of stones set on the upper floor. The nuts are taken out of gear by means of simple screw thread-operated iron jack ring assemblies.

On the upper (stone) floor are two pairs of stones; these were not easily accessible although they are thought to be French burrs, predominantly used for grinding corn. These were iron-banded and had been crudely balanced by pouring molten lead into recesses on the upper face of the runner stones. Later stones often used more sophisticated methods of adjustment, such as specially cast balance boxes. Wooden tuns surround the stones, feeding into appropriate chutes that direct the ground cereals into wooden arks on the ground floor. The "mill furniture" (hoppers, supports, etc) is exclusively of wooden construction, many years of continual adjustments of the crook strings having scored deep groves in the front support.

Grain was fed from the hoppers into inclined chutes that were continually agitated by means of unevenly-sided iron shafts (damsels), driven from the centre of the runner stones. The two damsels were different for each pair of stones, one using three raised ridges and the other, four. Their means of attachment to the runner stone also differed. Although much of the wooden equipment was riddled with woodworm and had clearly not been used for many years, it was still substantially complete and of considerable age,
