## THE MALTHOUSE, SEYMOUR HOUSE HOTEL, CHIPPING CAMPDEN, GLOUCESTERSHIRE

Amber Patrick

### Introduction

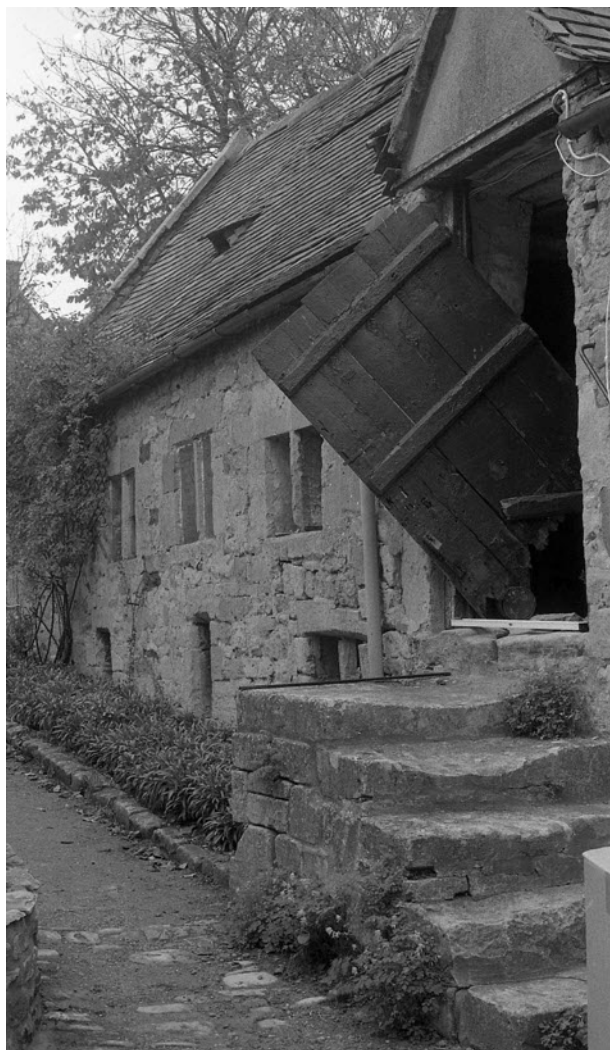
Fig. 1. The malthouse before work began, from the south east

The Malthouse first came to my attention in 1990. Then, it was in a very poor state of repair and it was used for miscellaneous storage (Figs. 1 and 2). Despite this the majority of its original internal features still survived: the steeping cistern, part of the couch frame, the hoist for moving the growing barley from the bottom growing floor to the top growing floor, and most importantly the kiln furnace and perforated tile drying floor on its stone supports. There were

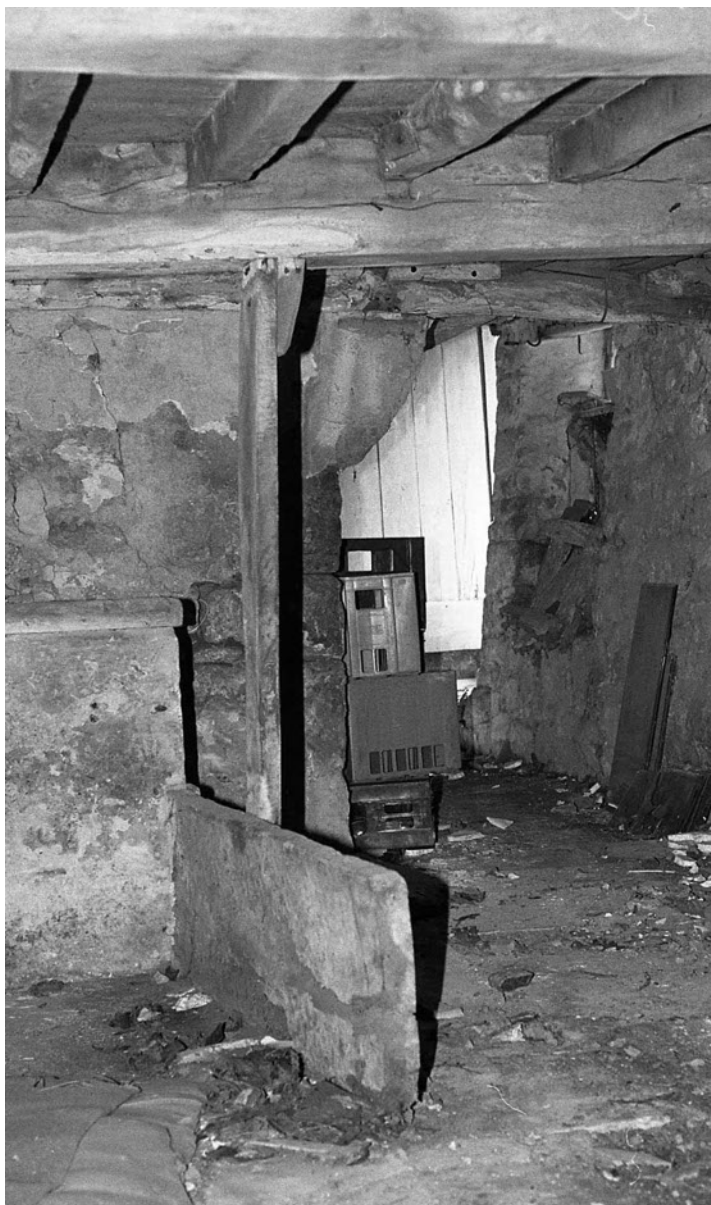
Fig. 5. The steep and the surviving part of the couch frame

north wall of the malthouse. It is constructed of stone blocks, generally large ones, but also with some smaller ones. The inside of the steep had a plaster lining which was surprisingly thick at  $\frac{3}{4}$  inch (2 cm). The drainage hole is in the centre of the bottom of the south wall. It is 6 inches (15 cm) across and  $5\frac{1}{2}$  inches (14 cm) in height and  $24\frac{1}{2}$  inches (61 cm) from the western end and 15 inches (38 cm) from the eastern, or kiln, end of the steep base. The drain hole simply drained into a soakaway in the floor. The steep is  $32\frac{1}{2}$  inches (81 cm) in height and 46 inches (117 cm) in width and 83 inches (211 cm) in length with the wooden lip being 3 inches (8 cm) in depth. The width of this wooden lip was  $8\frac{1}{4}$  inches (21 cm). Since the only means of emptying the wetted grain was by a man shovelling it out, it was hard work. The drain was only for draining off the water.

was positioned. The surviving south board was 18 inches (46 cm) in height and 64 inches (162.5 cm) in length, and the post was 4<sup>3</sup>/<sub>4</sub> inches (12 cm) by 5<sup>1</sup>/<sub>4</sub> inches (13.5 cm) and 64 inches (162.5 cm) in height. Later removal of the existing board revealed that it too had been seated in a groove. The measurements of the groove were 2 inches (5 cm) in width, and the length of the inside southern edge was 62 inches (157.5 cm) and the outside edge was 63 inches (160 cm). The western groove was 36 inches (91.5 cm) long on its outside edge and 34 inches (86 cm) on its inside edge. As is obvious this was not the full length of the steep. It is truncated by a stone flag. Whether this was a later replacement or because it was never the intention to have that part of the couch board in a groove it is not possible to determine.

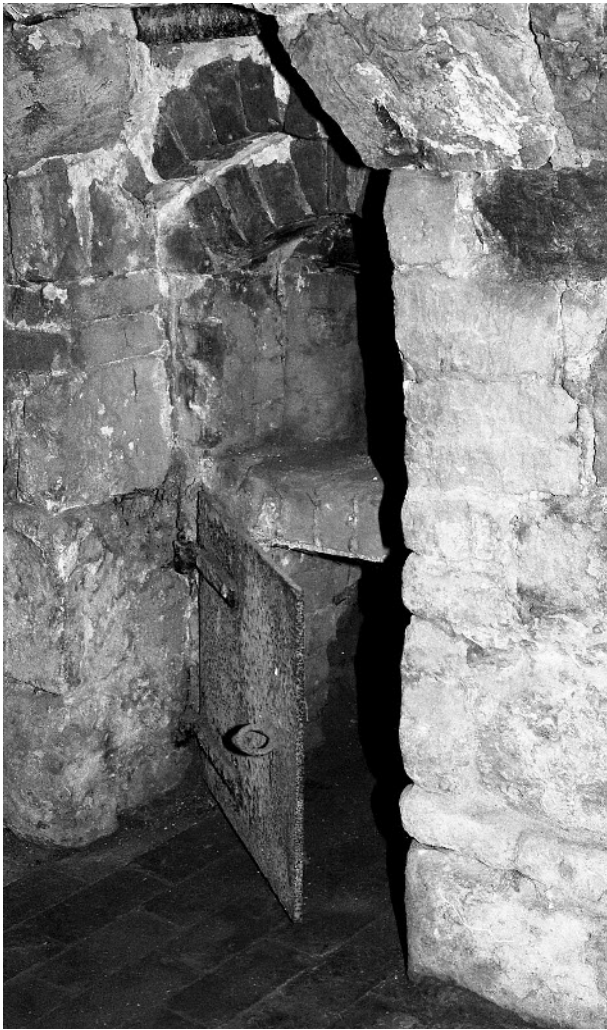
Fig. 6. The kiln furnace after cleaning

The kiln furnace is a robust structure of stone with some brick. The furnace aperture faces south. The fire bars of which there are seven survive as does the iron door to the lower opening from which the ash was removed. As the furnace structure is of stone it does not form the more usual barrel vault arches to the outside walls. Instead the massive stones of which it is constructed are cantilevered out so that the upper part of the structure forms a square of approximately 12 foot (3.7 m). The large stones at the back have an overlap of about two inches (5 cm).

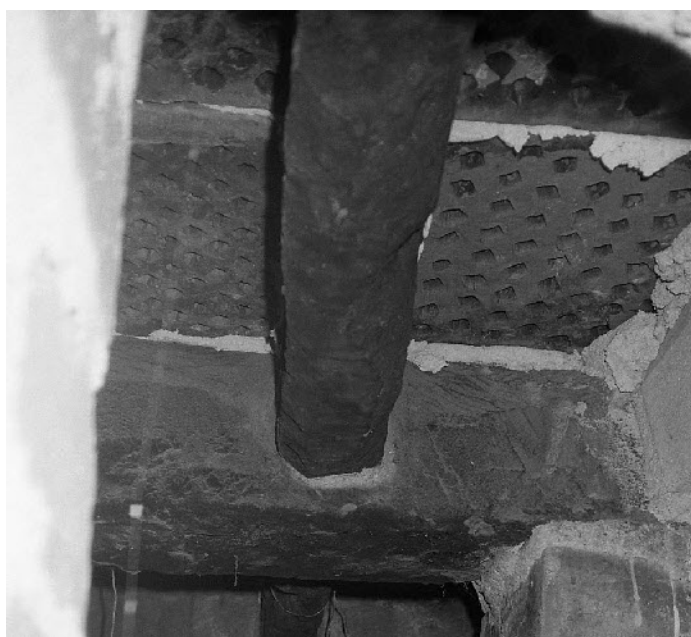
Fig. 8. The spark plate and the stone grid above it on which the perforated kiln tiles rested

inserted. Many of the stones in the kiln were hand dressed. Some of the stone piers and joists are quite blackened. The piers rest on a brick 'bed' which is 3 inches (8 cm) deep. The bricks rest on a bed of lime dust which is also 3 inches (8 cm) deep and in turn this 'rests' on the stone structure. The brick shaft of the furnaces rise up into the brick bed and above it is a spark stone or baffle plate of stones rather like roofing tiles. The spark plate was supported on brick piers and on top of it were short brick piers to support the stonework matrix. The depth of the furnace shaft is 40½ inches (102 cm) and it measures 50 inches (124 cm) (east to west) and 53 inches (134 cm) north to south. There is a slight slope of the floor to the shaft. The spark plate is 49 inches (124 cm) east to west and 54 inches (137 cm) north to south.

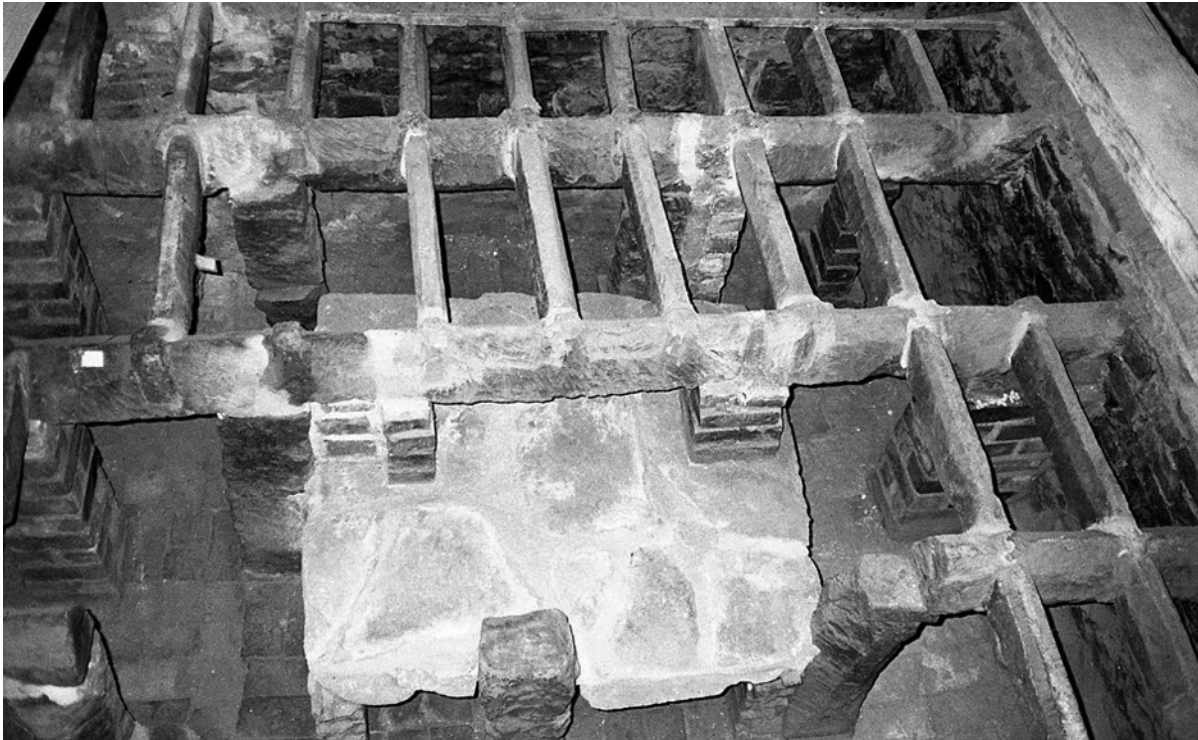
The drying floor which is of perforated tiles is square with the inner sides sloping. The tiles which are twelve inches (30 cm) square rest on stone bearers, the dimensions of which are a 2 inch (5 cm) surface (on which the tiles rested, giving an inch (2.5 cm) overlap to each tile) and a depth of 6 inches (15 cm) and a base width of 2½ to 3 inches (6 to 8 cm). These bearers fit onto another grid of horizontal bearers which have a top width of ¾ inch (2 cm), a depth of 9 inches (23 cm) and a base width of 6 to 7 inches (15 to 18 cm). These bearers are thus wedge shaped. They in turn rest on squared stone columns, although some additional brick piers have been

Fig. 9. Underside of stone grid showing underside of kiln tiles and some of the grid support pillars
