## **MILLS IN THE INCHBROOK VALLEY**

Mitchell Pollington

### **Introduction**

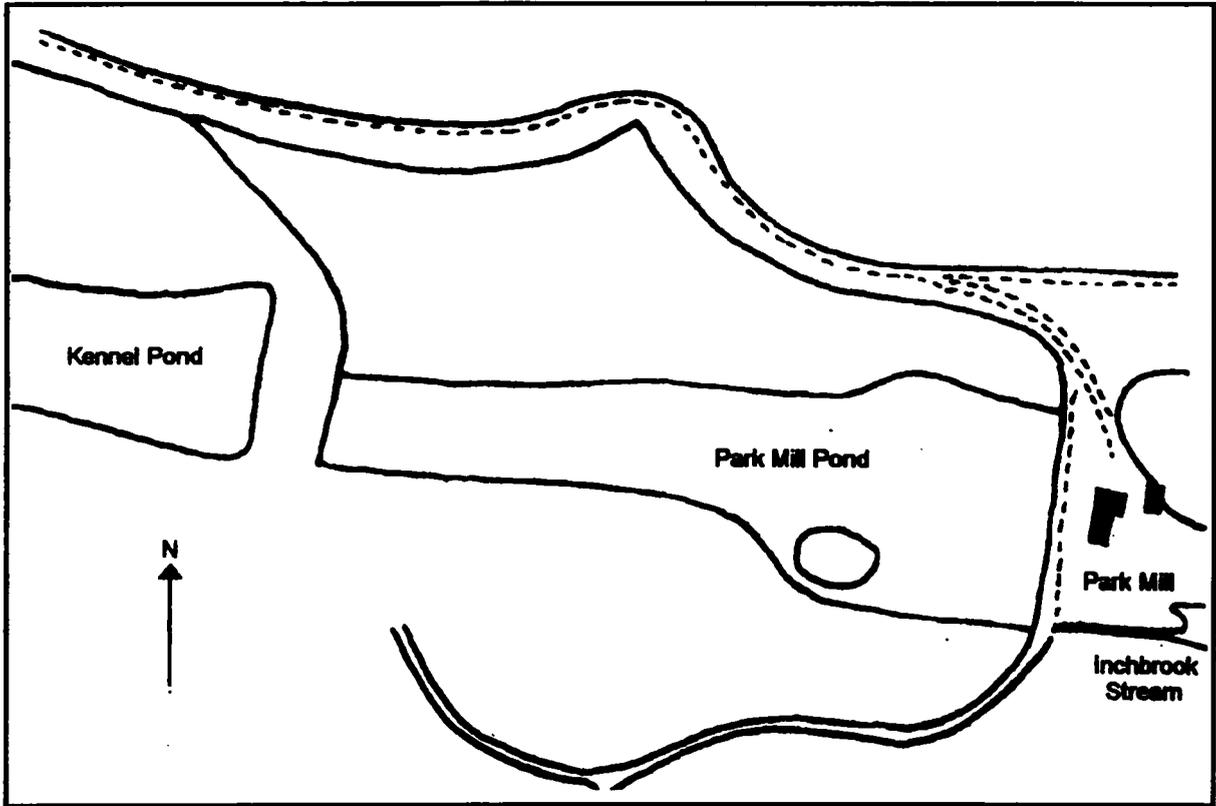
**Fig. 1** Extract redrawn from the 1782 map by John Spyers showing Park Mill (GRO D1011 P8).

The Park Mill is clearly shown on the early estate maps, and is also mentioned throughout the nineteenth century in a number of written sources. Although it is first shown on the Taylor map, the greatest detail on the structure of the mills buildings comes from the detailed estate map produced by John Spyers in 1782 (Figure 1). He was Capability Brown's partner and he subsequently carried out major alteration to the park, removing the formal gardens and introducing a much more open landscape. His map shows the mill to be a substantial structure abutting the dam side, laid out in an 'L' shape. On its eastern side lay a smaller ancillary building, and it was between this and the main mill that access was gained from the roadway which ran along the lower valley slopes above the area of the mill. It is known that between 1777, the time that Spyers' survey, and 1800, that the mill was worked by at least two people: a James Thomas in 1780 and a Nathaniel Cook by 1792 (VCH 1976, 298). It appears that during this period no substantial alterations were made to the mill, as both the detailed estate maps of 1790 (Figure 2) and 1800 (Figure 3) show the mill as it was when Spyers surveyed the site. The former map was produced after Ducie had purchased land here from John King. The later estate map of 1800 shows the mill but it lacks detail of earlier maps and it appears to have been produced to show the extent of the lakes which are highlighted vividly in blue and only the northern side of the estate is shown in any detail.

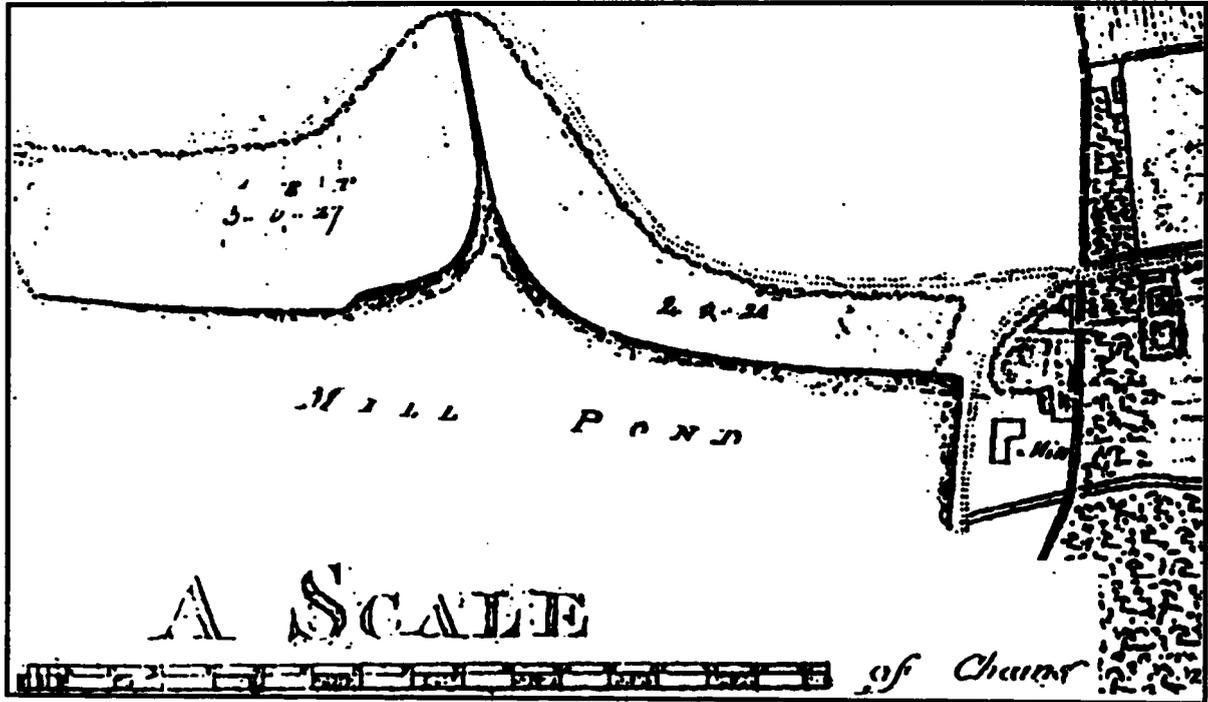
**Fig. 2** Park Mill as shown on the 1790 Estate Map (GRO D1011 P9).

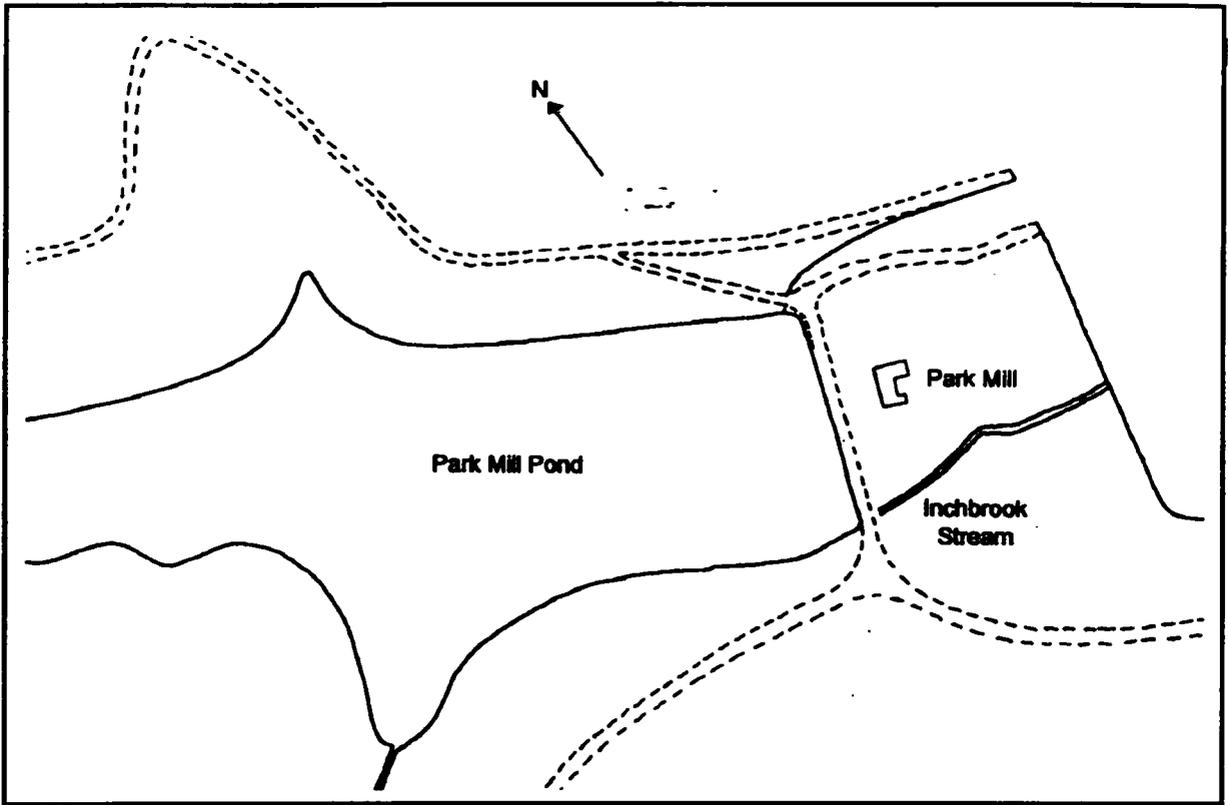
**Fig. 3** Extract redrawn from the 1800 map showing Park Mill (GRO D1011 P10).

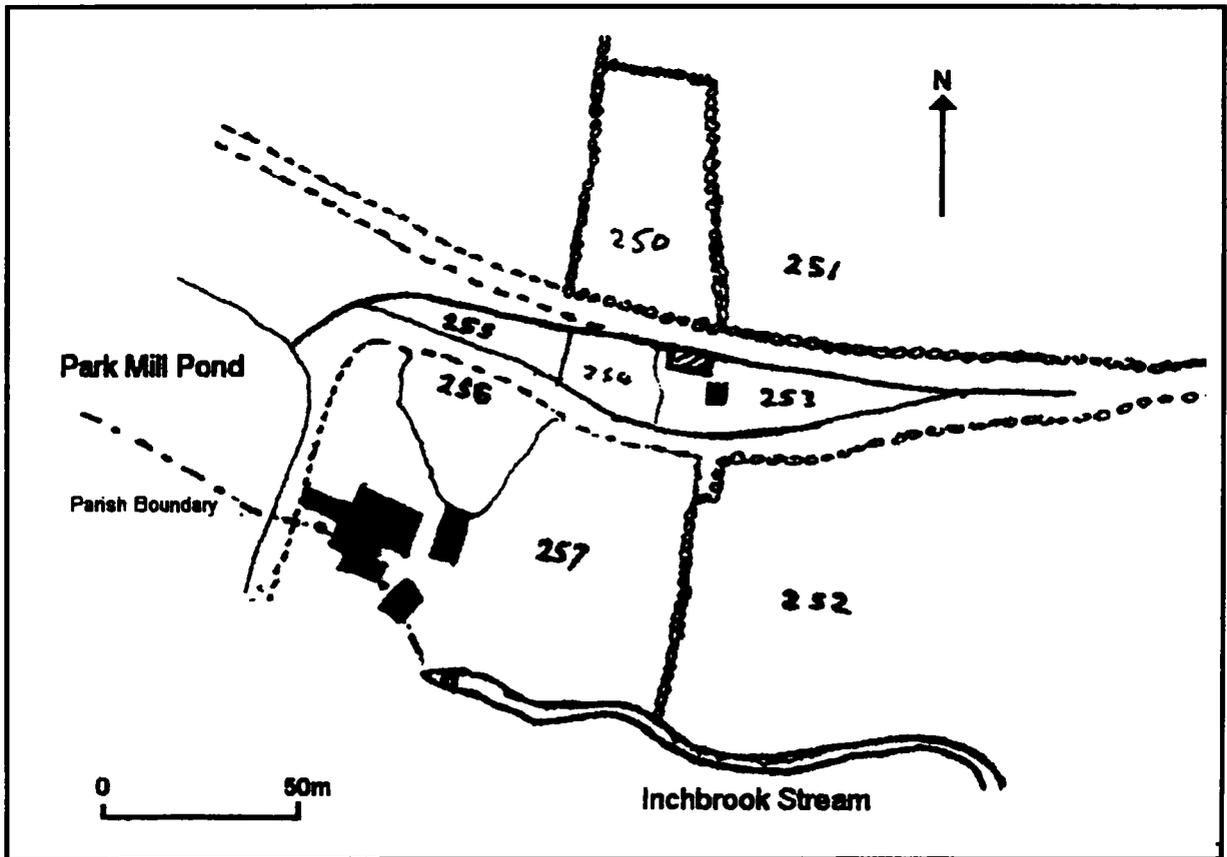
**Fig. 4** Detail of Park Mill from the 1838 Tithe Map (GRO TI/201 Redrawn by R. Wilson).

By 1838 however, when the tithe map for this area was produced (Figure 4), it is clear that there had been a number of major additions. On the western side of the mill a two storey wing was added, which abutted the dam, perhaps to allow easier access into the mill from the top (Wilson 1994, 29). There were further alterations on the southern end of the mill, as well as the construction of a secondary ancillary building.

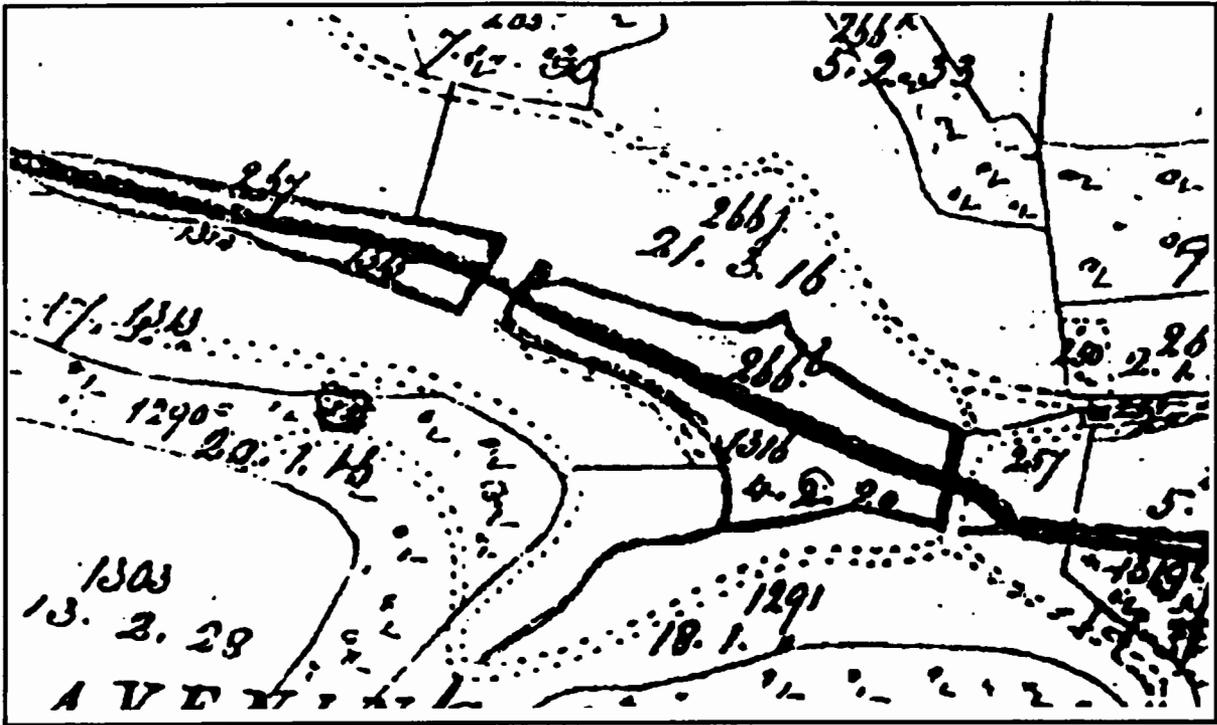
Fig. 5 Detail of Park Mill from the 1859 Estate Map (GRO D1011 P11).

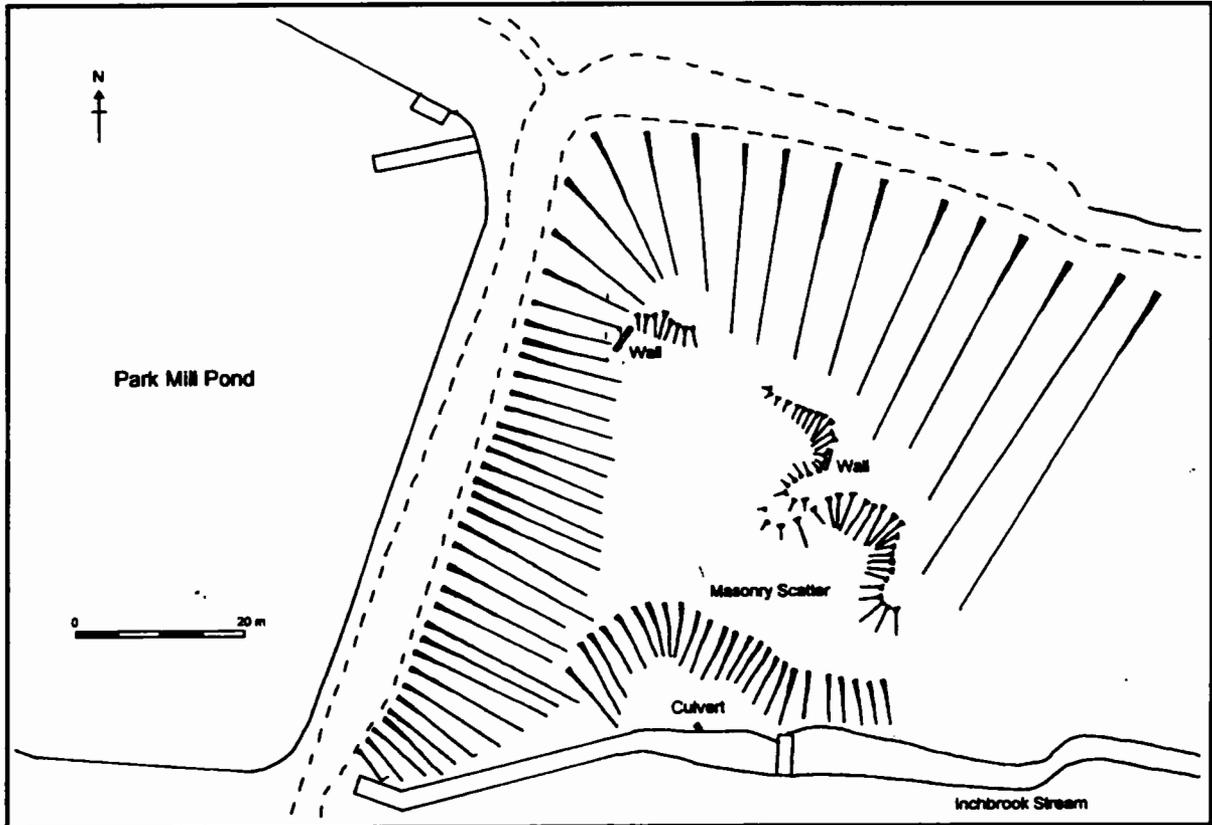
Fig. 6 The Earthwork Survey of the Park Mill site.

Further parts of the structure survive to the east of this a section in the form of rectangular cuts into the natural hill slope. An L- shape cut seems to represent the north-eastern corner of the main mill building . In the very corner of the section of earthwork running north-south is a small area of stone walling, presumably part of the main mill building's eastern wall. The line of the earthwork cut running east-west aligns with the remains of the wall against the dam presumably indicating the location of the northern wall of the building. A further rectangular cut into the slope, running on a north-south orientation, would seem to represent the area of one of the mills ancillary buildings, although there appears to be no masonry in situ currently visible. From these earthwork remains and the masonry structural remains it is possible to define on the ground the basic plan of the northern part of the main mill building, as well as the secondary structure. (Figure 6)

The earthwork survey was carried out using plane tables, tape measures and an alidade. Although this was satisfactory on the more level areas of the site, the nature of the topography and the size of the dam abutting the site meant that this method was often restrictive. It is recommended that a further survey be carried out using an Electronic Measuring Device, which was unavailable at the time of writing.

The initial observations showed that large cuttings had been made into the slope on the northern side of the site. These cuttings possibly indicate the position of former structures. Furthermore, there was a large scattering of stonework in the area in which the mill is known to have stood. This stonework appeared to be the remains of building masonry. A more detailed earthwork survey confirmed these initial findings: the stonework did indeed represent the surviving remains of the mill's fabric (Figure 6 - above). This confirmed that the cuts in the natural slope on the northern side of the sites were on the same alignment as the buildings shown in the latest map available of the site, the 1838 Tithe map. Two sections of walling built into these slopes were recorded, and are probably all that remain of the mill's structure in its original location. An area with a more dense concentration of stone blocks was recorded, but they appear to represent fallen masonry rather than sections of walling or foundations. This area of stone blocks approximates to the ancillary building to the south of the main mill,

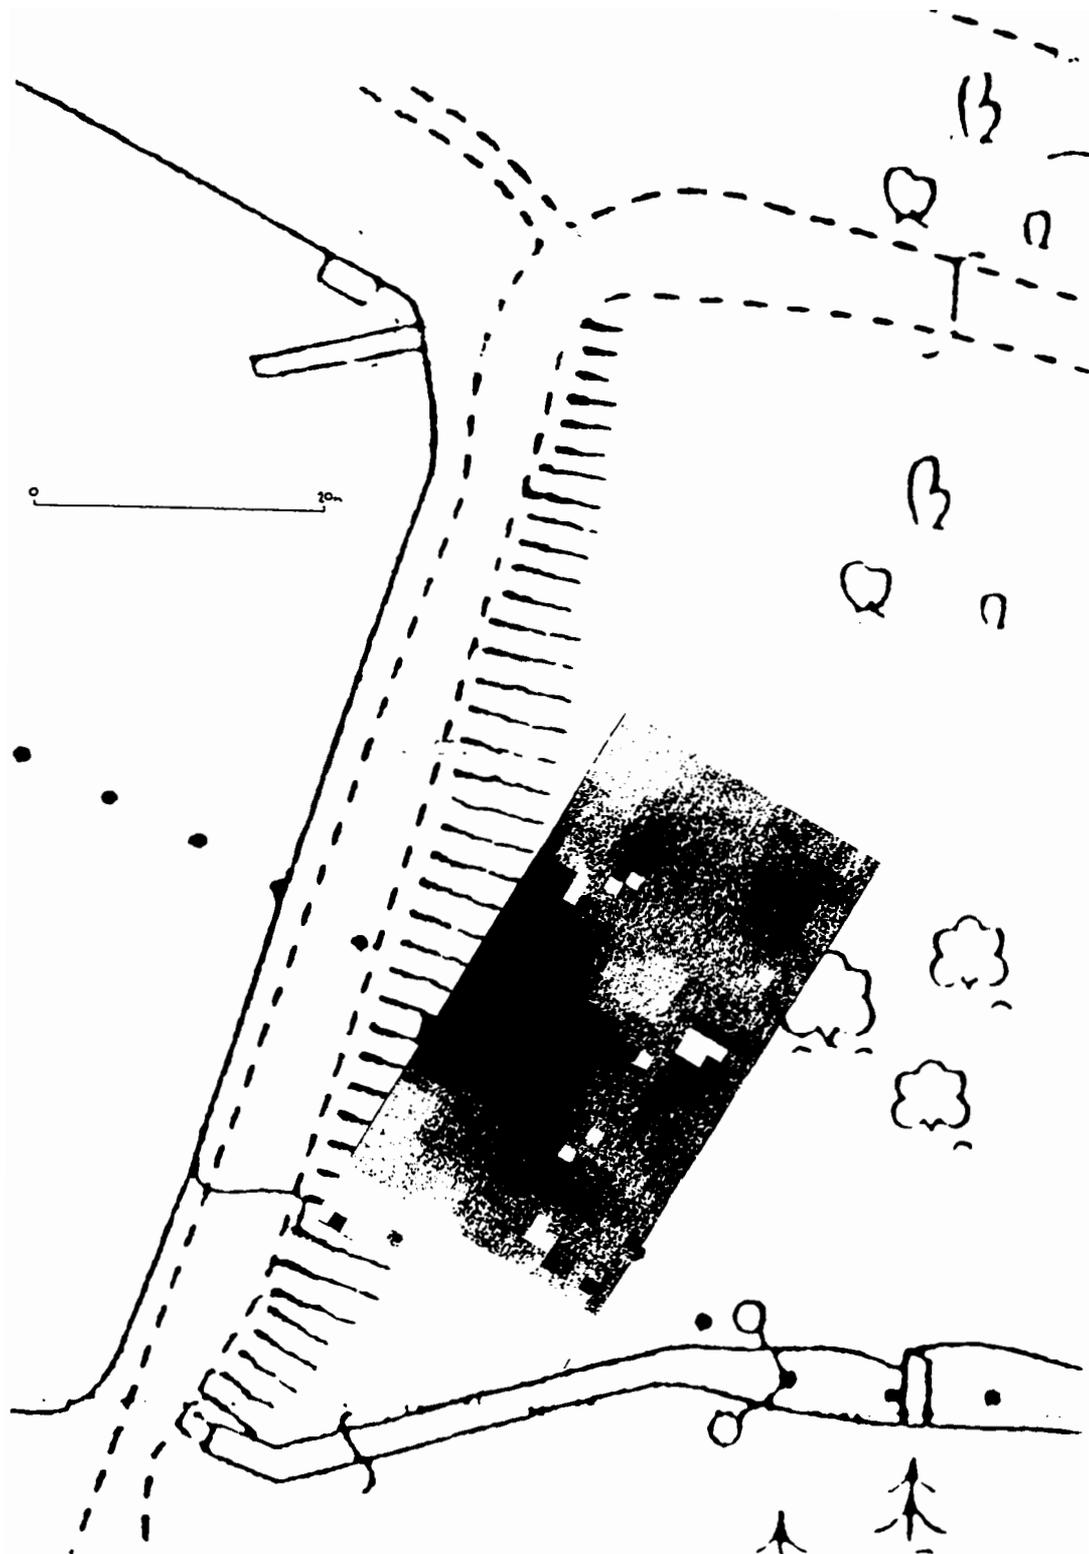
Fig. 7 The Resistivity Survey of the Park Mill site.

Overall, however, the results of the resistivity survey were disappointing in that the aim of identifying the elements of the mill's workings were not achieved through this method. The wet nature of the site, due to nearby springs, and the weather conditions contributed to these poor results. An area of high resistance was identified at the bottom edge of the dam (Figure 7). It appeared to be regular in shape with a well defined corner. From its location it would seem likely that the area of high resistance on the dam edge represents the corner of part of the western side of the mill building. It is known from documentary sources, including the Tithe map (GRO TI/201) and an engraving of 1809 (BL Maps K Top.13.18), that a wing extended out of the western side of the mill and onto the dam side, to allow direct access from the dam top into the upper story of the mill. It would appear that this represents the foundations of this part of the mill.
